**Pacific Northwest  
National Laboratory**

Technical Letter Report

**Preliminary Assessment of NDE  
Methods on Inspection of HDPE  
Butt Fusion Piping Joints for  
Lack of Fusion**

May 2008

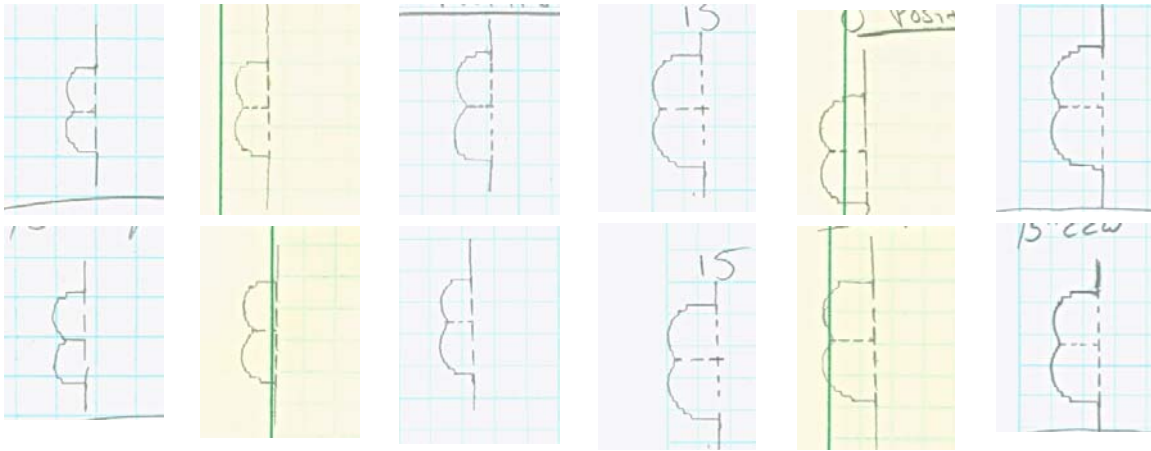
**Figure 3.2.** Weld Bead Profiles Taken Left to Right from a Pipe Fused at Conditions 1–6. The top profile was acquired at zero degrees and the bottom at 135 degrees. The grid spacing is 0.25 inch (0.64 cm).

The left and right weld bead widths, total width, and left and right bead heights were measured for the 24 fused pipes at eight positions around the pipe or approximately every 45 degrees. Figure 3.2 shows from left to right, two profiles taken from one pipe in each of the six fusion conditions. The top profile was taken at 0 degree, the print line of the pipe, and the lower profile at 135 degrees. Notice that the beads in conditions 1–3 are smaller than the beads fused with conditions 4–6. The average difference in left and right bead width and height was 0.67 and 0.34 mm, respectively, with no apparent correlation between the good four welds and the other welds expected to contain LOF. Also calculated was the average bead width-to-height ratio, which should be in the 2 to  $2\frac{1}{2}$  range. Figure 3.3 shows the results for this calculation for each of the 24 pipes. Joints fused with fusion pressure during the heat cycle, conditions 1–3, were out of bounds in the width-to-height ratio and the beads were smaller in these joints as already mentioned. With fusion pressure during the heat cycle, the weld bead width was approximately 15 percent smaller and the bead height 32 percent smaller than a bead with a normal heat cycle.

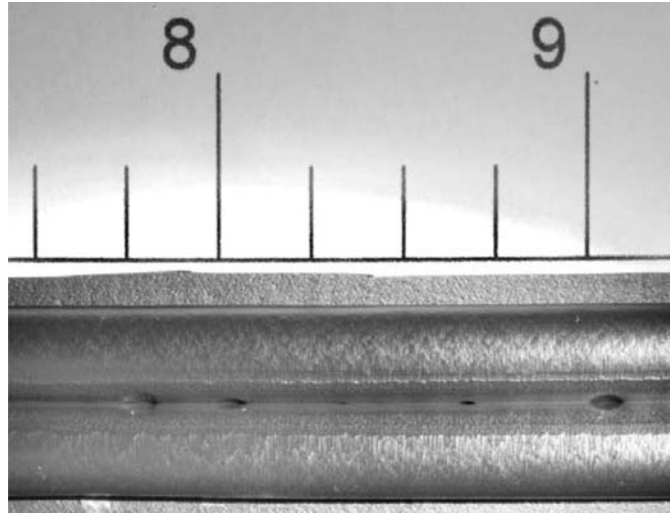
The weld bead fusion zone from the outer diameter (OD) of each pipe was visually inspected and areas with anomalies were photographed. Typical anomalies were voids or dimples in the v-groove between the weld beads as shown in Figure 3.4. In general there was little or no correlation between the VT results and the ultrasonic TOFD data from the Fluor/NDT Innovations, Inc. workshop, which is discussed later. As an example, one pipe contained many TOFD indications with 70 percent of the pipe fusion zone showing flaw signals. From the VT results, only four small defective areas were noted in the fusion joint from an OD inspection.

**Figure 3.4.** Fusion Zone Anomalies. The scale is in inches (1 inch = 2.54 cm).

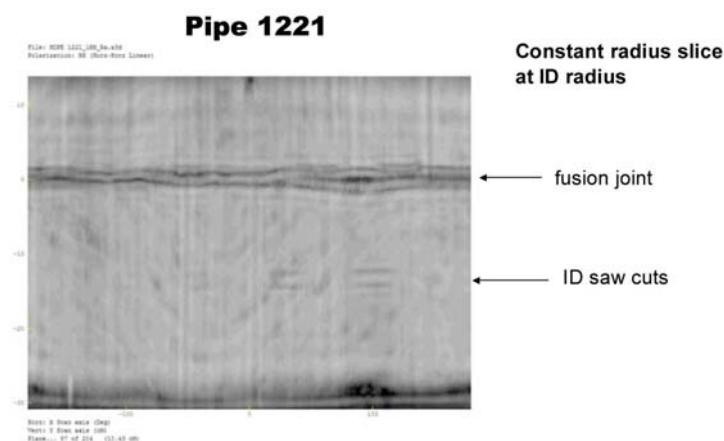
**Figure 3.6.** Typical U-Band Image Slice at the ID Surface

The method of displaying the image of the ID surface showed promise as it shows the shadow of the material variations.

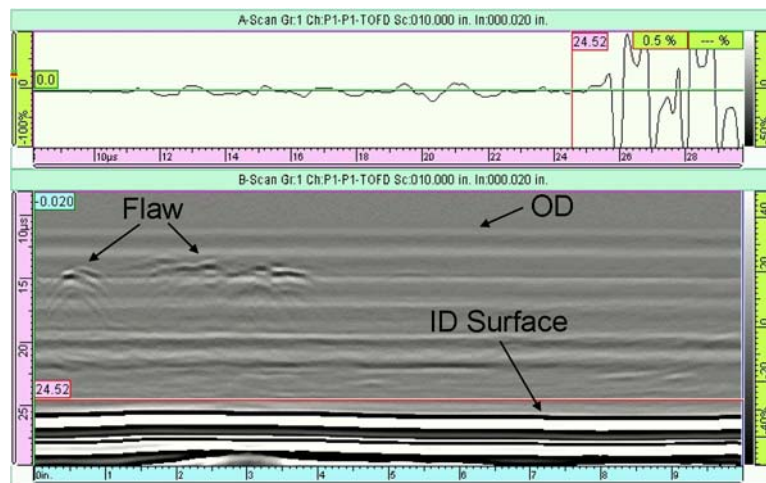
A screen capture for a 10-inch (25.4-cm) section of pipe, one quadrant, is shown in Figure 3.8. The upper portion of the image shows the A-scan, amplitude–time trace. The lower portion shows the B-scan gray-scale image of the inspected 10 inches (25.4 cm) of fusion zone. An OD surface signal (lateral wave) runs across the top of the B-scan image and towards the bottom is the ID surface signal (back wall echo). Embedded flaw signals occur between these two signals. An OD-connected flaw typically disrupts the OD surface signal and an ID surface-connected flaw typically disrupts the ID surface signal. Several flaw signals are noted in the left portion of the image and are representative of the hyperbolic diffracted signals seen in a TOFD inspection. The technique relies on a disturbance of the base material signals caused by flaw tip diffracted signals.

**Figure 3.8.** TOFD Image Showing the OD and ID Surface Signals and a Flawed Area

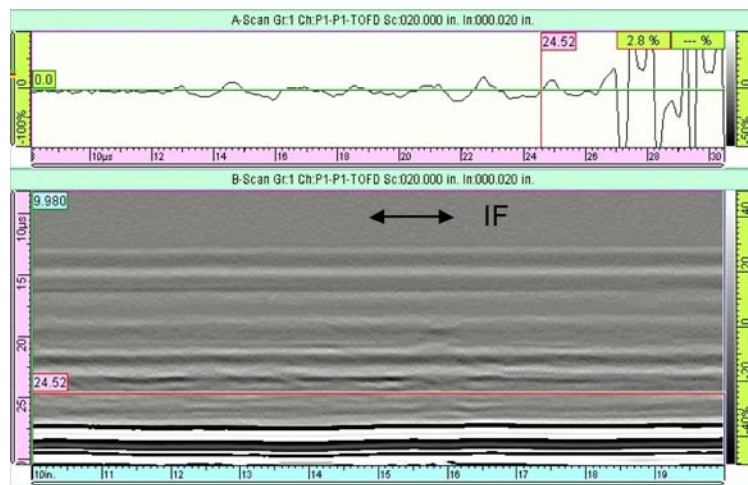
In general the technique appeared to detect acoustical anomalies in the pipes. Figure 3.9 shows an area that was identified as having incomplete fusion. Figure 3.10 shows an area called flawed in one of the good pipes, fusion condition 6. Images of all the data are shown in Appendix B. Destructive analysis is needed to verify these results. These calls, as noted on the images, were made by NDT Innovations personnel during their two-day inspection of all 24 joints. Some of the calls are obvious as in Figure 3.8 and others are less obvious as in Figure 3.9. It also needs to be noted that the original data had high resolution and contrast, which unfortunately is reduced in these figures.

**Figure 3.9.** Area Identified as Incomplete Fusion

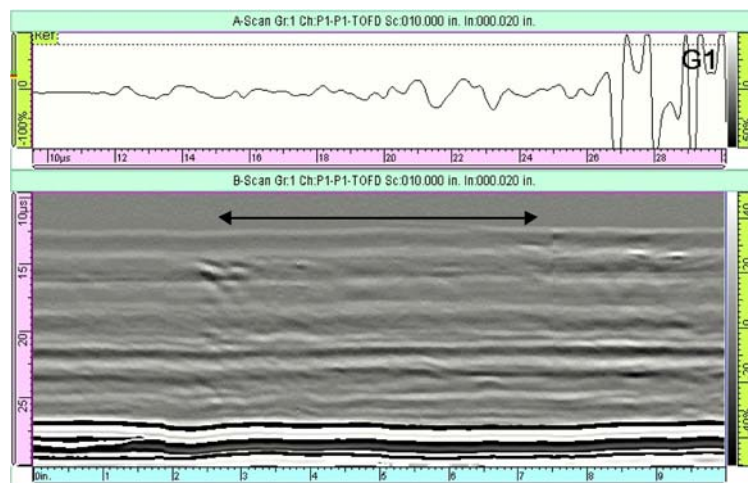
**Figure 3.10.** Possible Flaw Indications in One of the “Good” Pipes

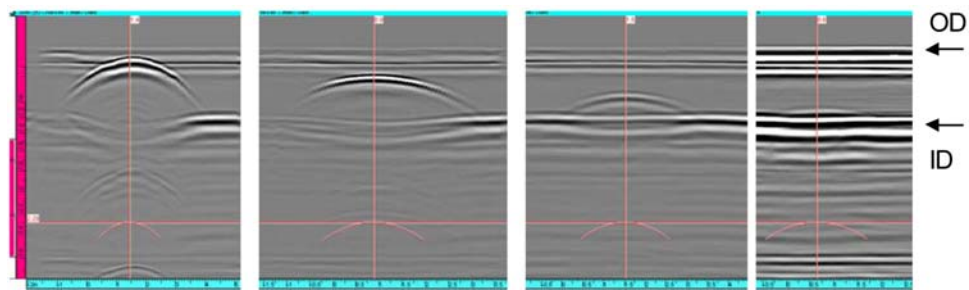
Responses from the ID sawcuts acquired at 52 dB of hard gain and no additional soft gain are shown in Figure 3.12 for the 75, 50, 25, and 10 percent through-wall deep flaws. These sawcuts were placed in the base material. The 5 percent deep notch was not detected. Note that the deeper two flaws are saturated and greater in response than the lateral wave. The 25 percent deep sawcut is 5 dB lower in amplitude and the 10 percent deep notch is 18 dB lower than full scale at the base gain level of 52 dB. The time or depth (vertical direction) window shown in these sawcut images extends beyond the ID or back wall echo. This allows viewing of mode-converted signals (longitudinal to shear) that can add additional information to the material inspection. This is an area for further investigation.

**Figure 3.12.** PNNL TOFD Results from Four ID-Connected Sawcuts. From left to right the through-wall depths are 75, 50, 25, and 10%.

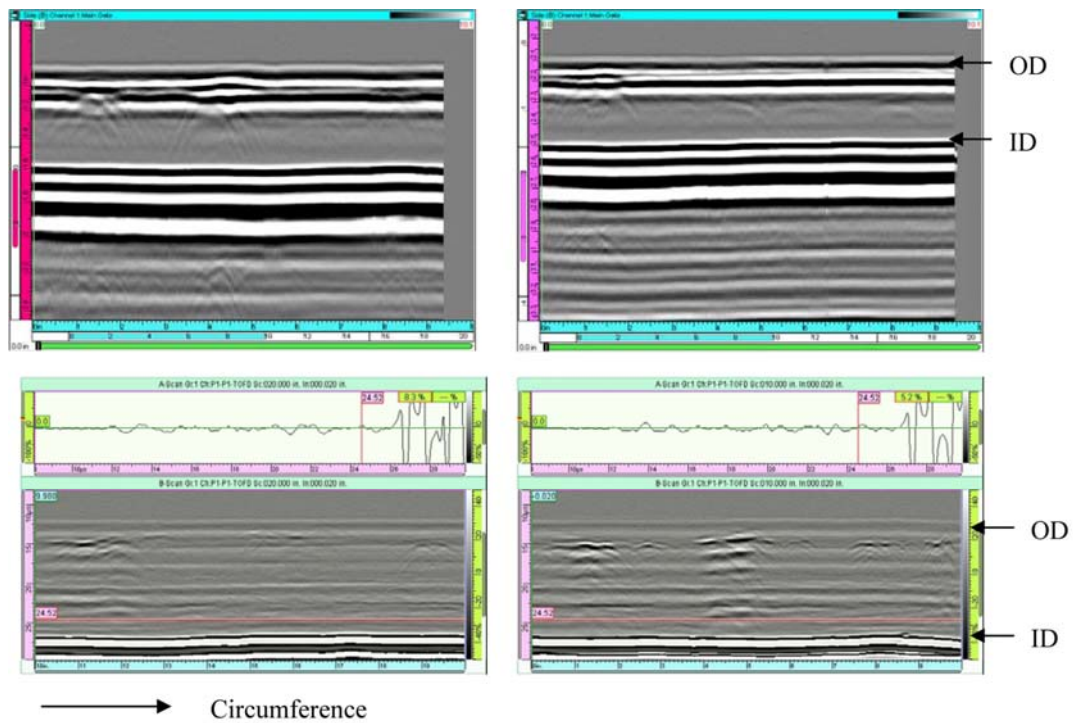
The worst-case condition for pipe fusion, out of the McElroy batch of 24 test assemblies, and the one most likely to produce LOF was condition 2 with fusion pressure during the heat cycle and a 20-second open/close time. One of these pipes was examined with TOFD by PNNL showing results comparable to those presented by Fluor/NDT Innovations, Inc. The data are shown in Figure 3.13 and Figure 3.14 for the four pipe quadrants, with the PNNL data shown in the top of each figure and the Fluor/NDT Innovations, Inc. data at the bottom of each figure. Notice that the PNNL data show the mode-converted signals beyond the longitudinal-wave back wall (ID) echo. The time window was extended to include the slower mode-converted signals with the thought that this additional data would enhance the detection of defects. The Fluor/NDT Innovations, Inc. data images are cropped at the ID and additionally do not have the saturated OD lateral wave signal seen in most TOFD images and in the PNNL data. This results in a cleaner looking image and should provide better near-surface sensitivity to flaws. Fluor/NDT Innovations, Inc. data is also much more sensitive, due most likely to their patented processing of the raw data. Regardless, in this data comparison flaw indications are identified at similar locations by both PNNL and Fluor/NDT Innovations, Inc. Each quadrant represents approximately 10 inches (25.4 cm) of pipe circumference.

**Figure 3.13.** TOFD Data Acquired on Pipe 125, First and Second Quadrants (left and right), by PNNL in the Top and by Fluor/NDT Innovations, Inc. in the Bottom

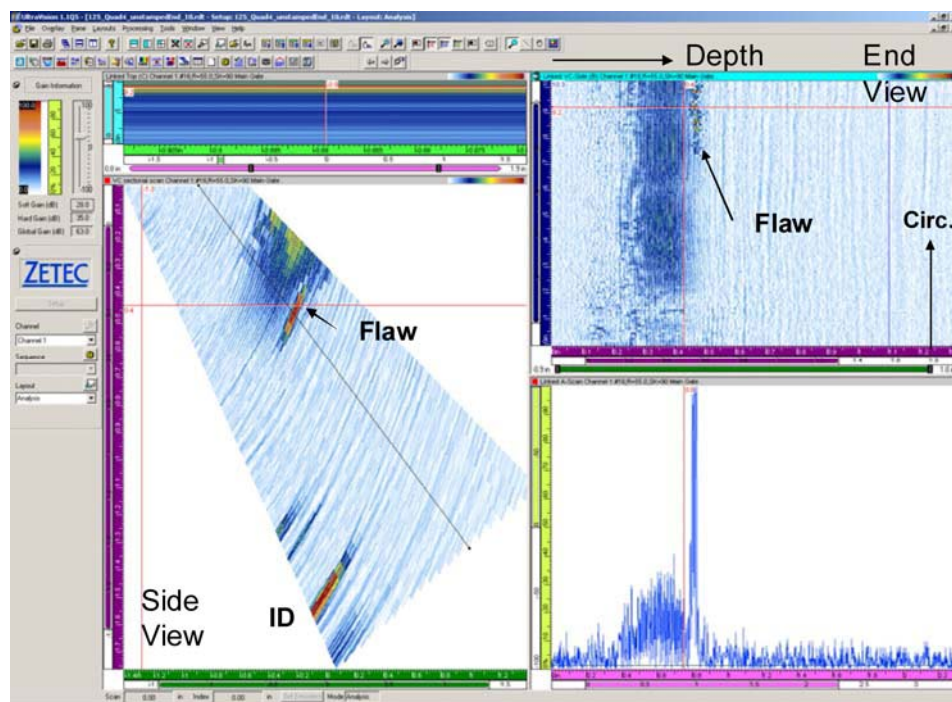
PA data was acquired on the fusion joint from pipe 125, a worst-case condition for joint integrity, and is displayed in Figure 3.17. The side view on the left shows the ID signal at the angle sweep start of 30 degrees. Data is acquired from 30 to 60 degrees at 1-degree increments. The highlighted flaw indication was centered at approximately 55 degrees as shown by the black line at the flaw indication in the side view. The associated end view at 55 degrees is shown on the top right with the flaw signal noted. Its circumferential extent is approximately from 7 to 9 inches (17.8–22.9 cm) in quadrant 4. The bottom right shows the A-scan trace from the position marked by the red horizontal line in the end view image.

**Figure 3.17.** Phased Array Results on HDPE Pipe 125, Quadrant 4 Showing a Possible Lack of Fusion in the Noted Flaw Area

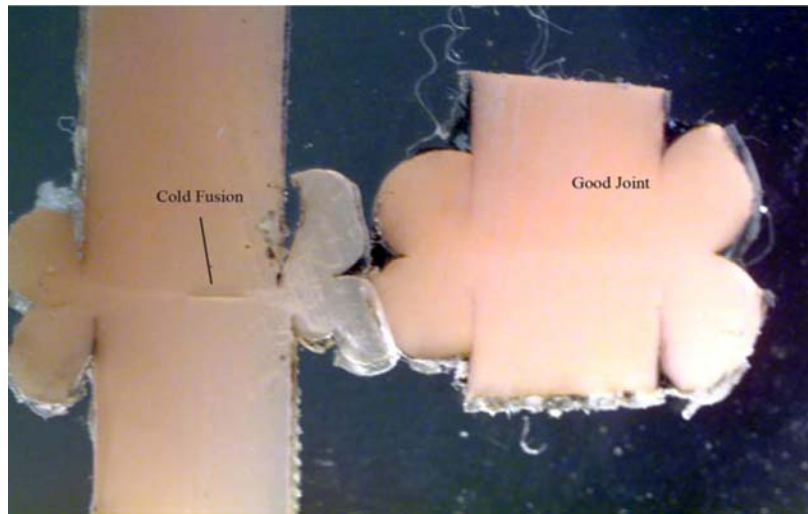
**Figure 4.1.** Cold Fusion and Good Joint in PE Material. Photo courtesy of Frank Schaaf.

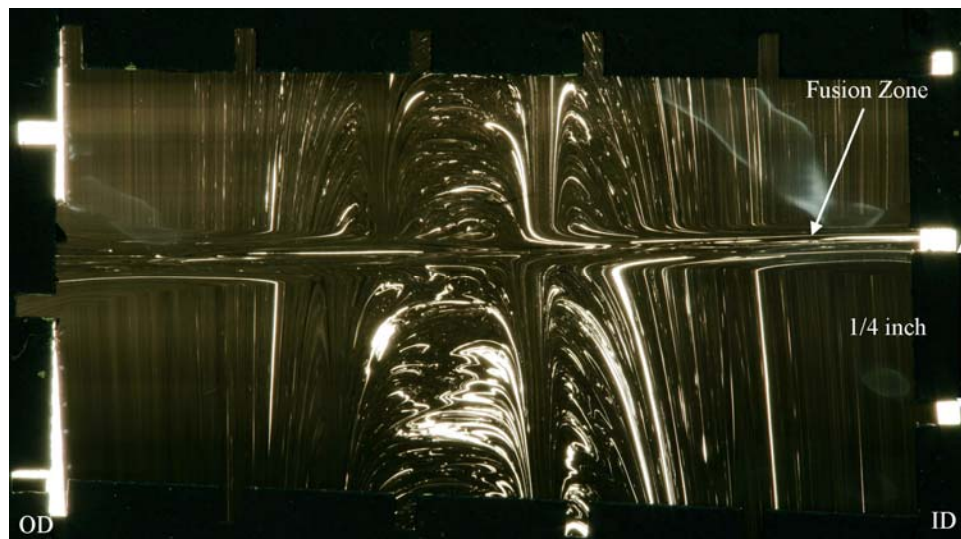
A weld area from pipe 125 containing a flaw indication at approximately 7–9 inches (17.8–22.9 cm) was cut out of the pipe. Slices were made in the axial direction, perpendicular to the weld. These slices were in the 25–35 micron thick range and were thin enough to see through yet thick enough to still hold together. A slice at approximately 8.6 inch (21.8 cm) in the pipe circumference is shown in Figure 4.4. Because of uneven mixing of carbon black in the base material of this 3408 pipe there are light and dark swirls in the pipe. In the joining of the two pipe sections, this swirl pattern changes direction due to the melting and fusing and runs along the fusion line. These light and dark lines in the fusion zone camouflage lack of fusion in this region. Evidence of lack of fusion is, however, seen on the cut (or sectioned) pipe surface as shown in Figure 4.5. The microtome cut is made from the bottom of the piece in Figure 4.5 to the top, leaving cut marks that run perpendicular to the fusion line. Sufficient and appropriate lighting or tilting of the pipe section highlights the lack-of-fusion lines in the fusion zone. A liquid penetrant test (PT) or evaluation of this surface was also performed in attempts to enhance the LOF indication. A red dye was applied to the cut surface and allowed to soak for at least one hour. Normally during this dwell time the liquid penetrant is absorbed into surface discontinuities by capillary action. After the dwell time the surface was wiped clean of the dye and a white developer applied. The developer typically draws dye out of discontinuities and maps out the flaw shape/opening on the surface of the specimen. No flaw was seen on this specimen face with the PT. It is assumed that these LOF areas are so tight that the dye did not seep into the discontinuity.

**Figure 4.4.** A Slice from HDPE Pipe 125, Quadrant 4 at Approximately 8.6 Inches (21.8 cm). Lack of fusion in the fusion zone is not evident due to light colored material streaks and swirls from uneven base material mixing.

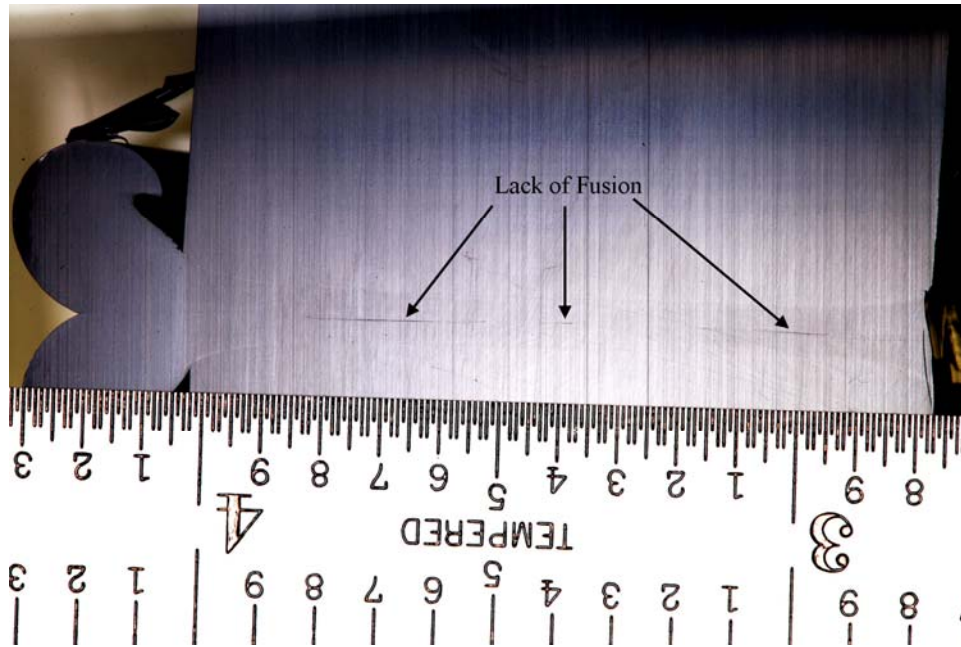
**Figure 4.5.** Surface of HDPE Pipe 125, Quadrant 4 at Approximately 8.6 Inches (21.8 cm). Areas of lack of fusion are noted.

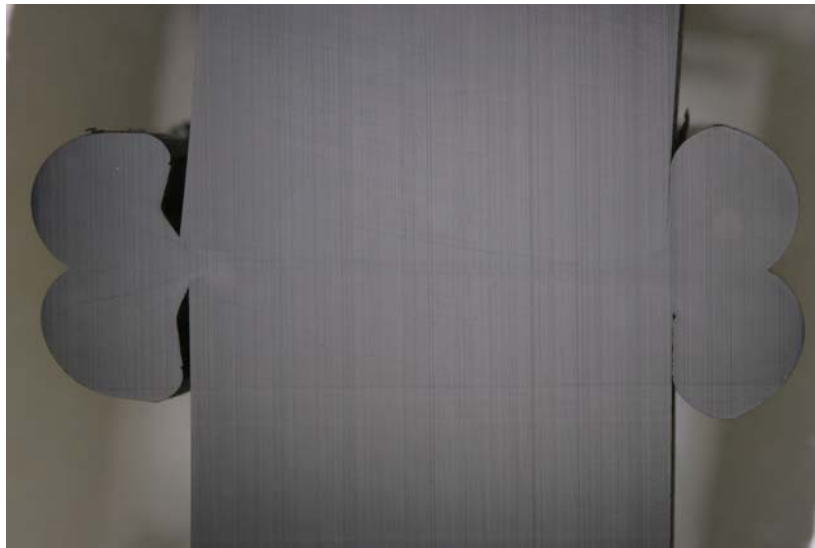
**Figure 4.8.** Surface of HDPE Pipe 1224, Quadrant 4 at Approximately 3.4 Inches (8.6 cm). No lack of fusion is seen.

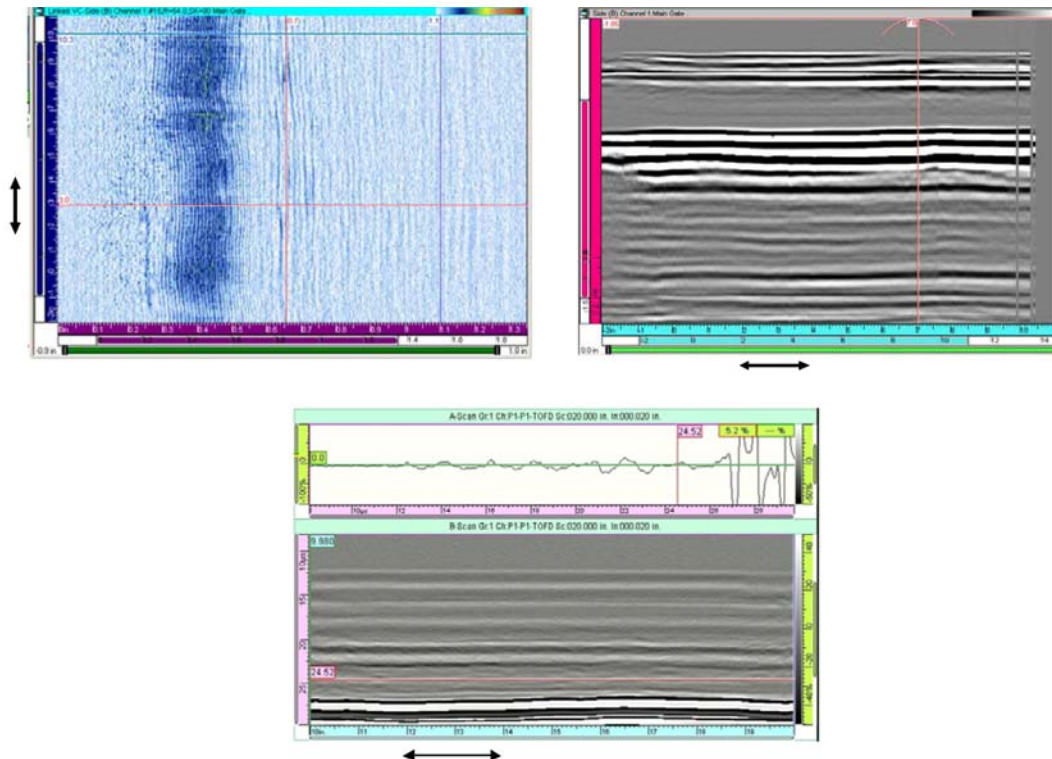
The ultrasonic responses from quadrant two in the fusion joint in this good pipe, 1224, are shown in Figure 4.9. The area marked with a double-ended arrow has been sent out for tensile testing.

**Figure 4.9.** Ultrasonic Responses from Quadrant Two of Pipe 1224 All Show No Flaw Indication. The PNNL PA data is in the upper left, PNNL TOFD data in the upper right, and Fluor/NDT Innovations, Inc. TOFD data in the bottom.

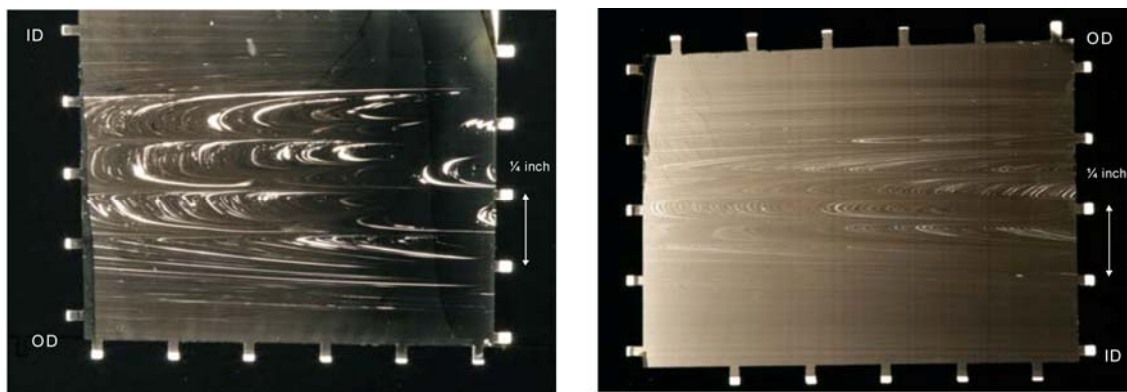
A preliminary evaluation of base material showed no ultrasonic indications in one 3408 pipe and one 4710 pipe. Slices from the 3408 and 4710 base material are shown in Figure 4.10, left and right, respectively. The spacing between the fiducial notch marks on the edges of each image is 0.25 inch (0.64 cm). The 3408 material is less uniformly mixed. The 4710 material still shows some nonuniformity but to a lesser extent. Even with this amount of swirling it would likely still be difficult to examine a thin slice through a 4710 fusion joint for LOF. No porosity was found in the few slices through base material. Only one or two areas were found with a single pin hole or porosity in or near a fusion joint in the numerous fusion joint slices evaluated. This could approximately represent a 1 percent or less rate of porosity in a slice.

**Figure 4.10.** Base Material Slices from 3408 on the Left and 4710 on the Right Show Swirls from Nonuniform Mixing. The spacing between edge notches is 0.25 inch (0.64 cm).
