## CAAP Quarterly Report

06/30/2024

*Project Name:* Easy Deployed Distributed Acoustic Sensing System for Remotely Assessing Potential and Existing Risks to Pipeline Integrity

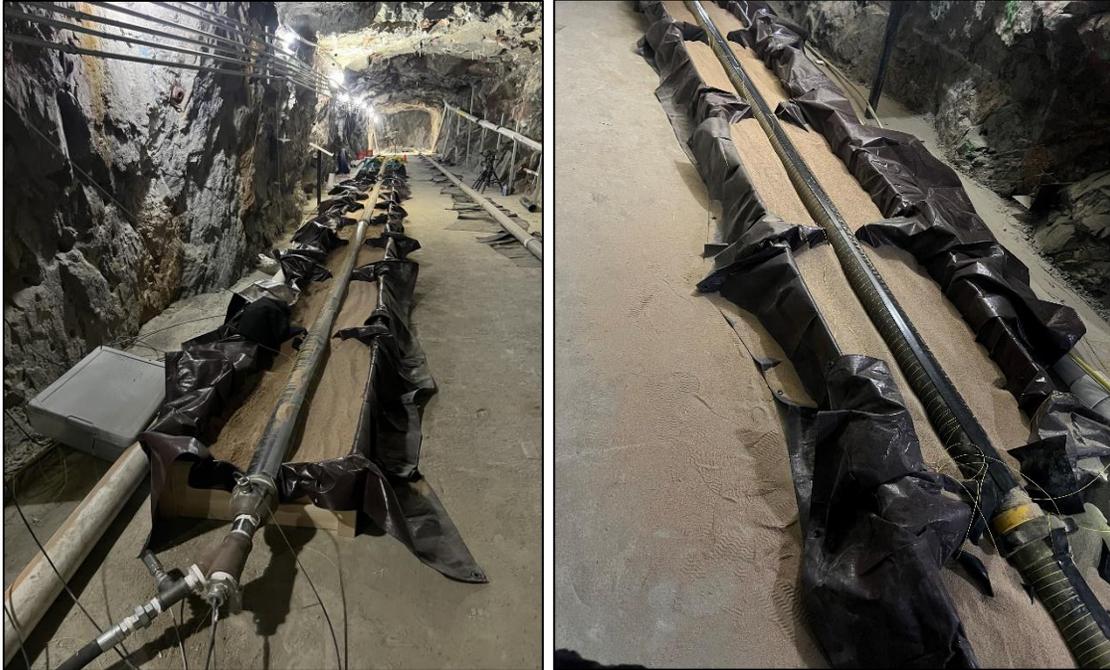
**Figure 1.** Pictures of the “unburied” pipeline.

2. We have successfully modified the pipeline layout from the “supported” to “unburied” configuration. The pipeline is now laid on sand, held by wooden boxes. This configuration facilitates easier execution of “buried” experimental studies in the next step. A tarp was placed underneath the leakage point to prevent blowing sand during the leakage experiment. **Figure 1** shows the picture of the pipeline setup, and **Figure 2** shows the picture of the 1-meter test section. The wooden boxes were halfway filled with sand before placing the pipeline on top. Additional sand was added to the sides to ensure the pipe remained steady and secure, minimizing vibrations. We anticipate observing different vibration patterns from the previous experiments using “supported” setup, which will be discussed in the next quarterly report.
