Public Quarterly Report

Project Title: Development of a Blade Toughness Meter (BTM) for In-situ Pipe Toughness Measurement

Prepared by: Massachusetts Materials Technologies

PHMSA Task 1.3 Final Deliverable Report

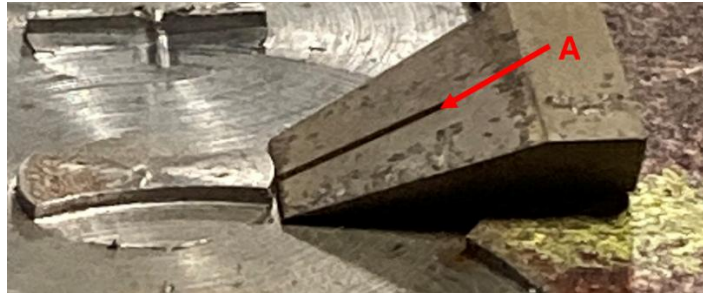
Figure 1: Blade with Labelled Stretch Passage (A)

Work on this objective primarily focused on exploring the effects of varying stretch passage widths on resulting material prediction ability, or material response consistency.

Two primary stretch passage sizes were tested, 0.015" and 0.020". A variety of measurements of the fracture surface resulting from these tests were collected and compared. The common criteria utilized to judge these measurements was whether or not they correlated with the K fracture toughness properties of the various steels in the testing program. One metric which reflect how well a group of measurements on various materials correlates with the toughness of those materials, is the coefficient of determination or " r^2 " value. Table 1 below shows the relative performance of the measurements produced by the 0.020" blades and those produced by 0.015" blades.

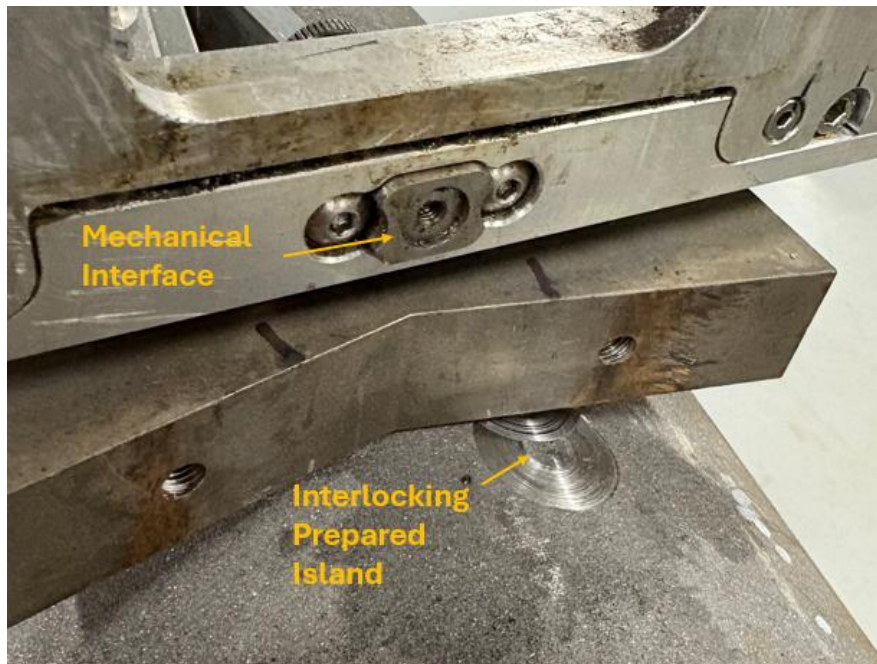
Figure 10: Mechanical Interface for Anti-Rotation

Item D took several iterations to successfully address. The original v1.0 design included a metal interface which would be intended to mechanically contact an additional prepared surface, resisting rotation around the pipe.

This approach saw some success but had two major draw backs: the preparation of the additional surface increased total wall thickness removal for the tool, and difficulty securing

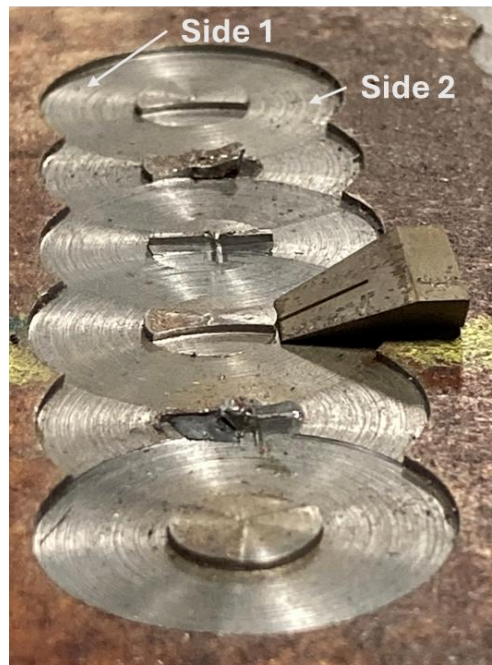
Figure 14: Prepared Surface with Side 1 and Side 2 callout

In the initial prototype, there was a measured difference in depth of the prepared surface from side 1 to side 2 in Figure X. This can lead to insufficient test depth on the shallower side. Upon investigation there were two potential sources; the entire frame was not sitting tangential to the pipe surface, the surface preparation sled was not sitting tangential to the pipe surface. In various cases either or both of these factors were causing the problem. In either case the fundamental issue was the datum of the surface preparation device had rolled or pitched out of alignment with the pipe surface.

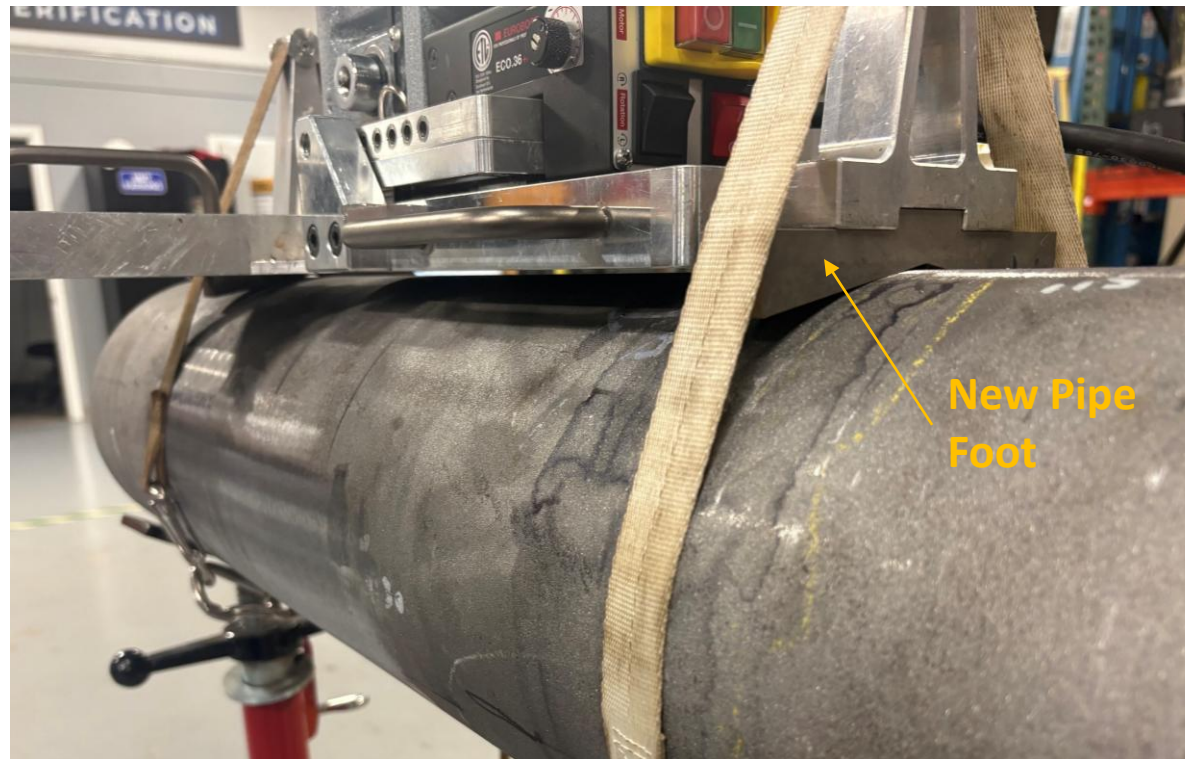
- Foot attachment improvement with diamond coating

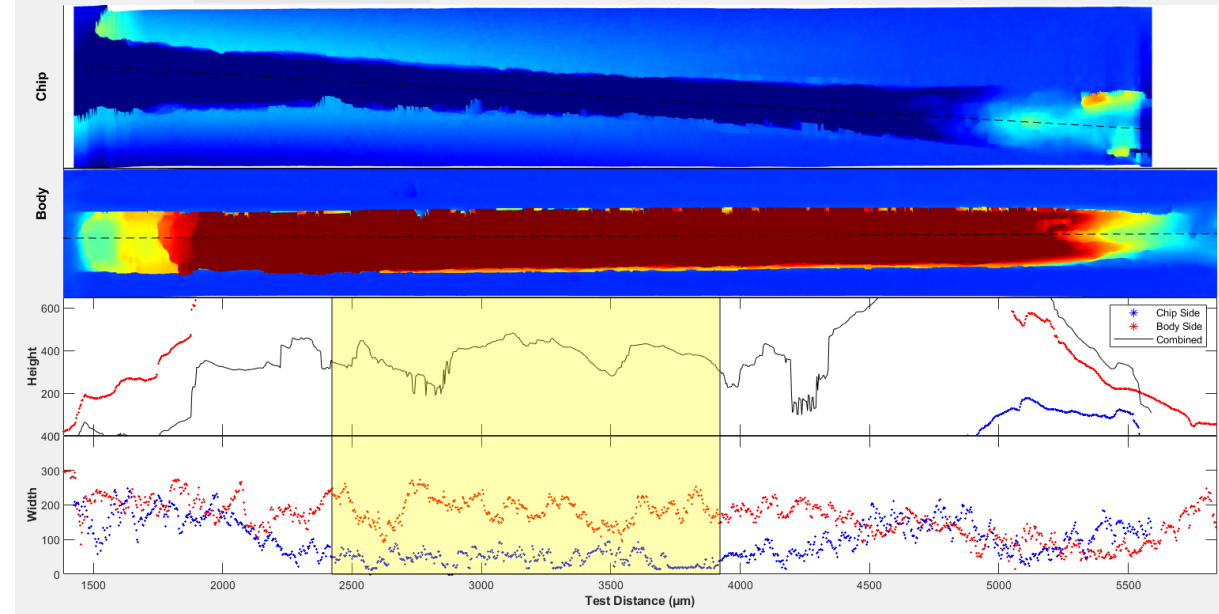
Bad test

| LHAvg: 375.581 | LHStd: 63.7041 | FRWAvg: 116.7039 | FRWStd: 77.7964 REJECTED
