# HYDROGEN ENVIRONMENT EMBRITTLEMENT OF LOW ALLOY STEEL AT ROOM TEMPERATURE

Y. WADA<sup>1</sup>, R. ISHIGAKI<sup>1</sup>, Y. TANAKA<sup>1</sup>, T. IWADATE<sup>2</sup> and K. OHNISHI<sup>3</sup>

<sup>1</sup>Muroran Research laboratory, Japan Steel Works, Ltd., Muroran city Hokkaido, JAPAN

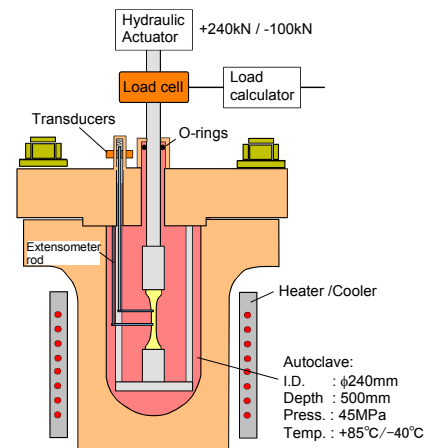
Pressure vessel with hydraulically actuated, closed-loop-controlled material testing machine has been developed. Figure 1 shows schematic drawing of the vessel. The pressure vessel has an inside diameter of 240mm and the depth of 500mm which is capable of standard cylindrical tension specimen ( $\phi$  8mm G.L.=50mm), fatigue specimen ( $\phi$ 8mm G.L.=15mm) and compact tension specimen (1T-CT) which are utilized in this experiments. The actuator capacity is 240kN in tension and 100kN in compression. Load calculator cancels load component raised from the pressure so that the external load cell can measure the specimen load only. Strain was measured by clip-on type extensometer or measured through the rod mounted to the specimen so that the transducers outside of the top projection of the autoclave detected the rod position. It is well known that the hydrogen environment embrittlement is affected by the purity of surrounding hydrogen gas since hydrogen environment embrittlement by gaseous hydrogen occurs by gas phase diffusion of molecular hydrogen to some critical location where metal is stressed and/or stressed crack surface. Hoffmann and Rauls [2] demonstrated that only 0.1ppm oxygen inhibits the hydrogen environment embrittlement. Fukuyama [3] reported CO and SO<sub>2</sub> gas inhibits the crack growth while H<sub>2</sub>S promotes crack growth. For such reason, to minimize the experimental uncertainty caused by impurity gases, hydrogen gas used for material testing is 99.99999% purity by volume with the following impurity levels: O<sub>2</sub><0.02ppm, CO<0.01ppm with a dew point of -80 °C . Pressurization and system purging is conducted before testing:(1) pressurization with dry N<sub>2</sub> gas, (2) evacuation and (3) pressurization/depressurization with the pure hydrogen gas. Test materials are JIS-SCM low alloy series: SCM435 and SCM440 which are the popular materials for the ultra high-pressure equipment. The chemical compositions are exhibited in table 1. Since specimen surface conditions are known as the factors affecting the hydrogen tension test results (ASTM-G142-98[4]), specimens are prepared by 1) Highly polished by abrasive papers, 2) Electro polished by 0.2mm in

Figure 1 Fatigue testing machine

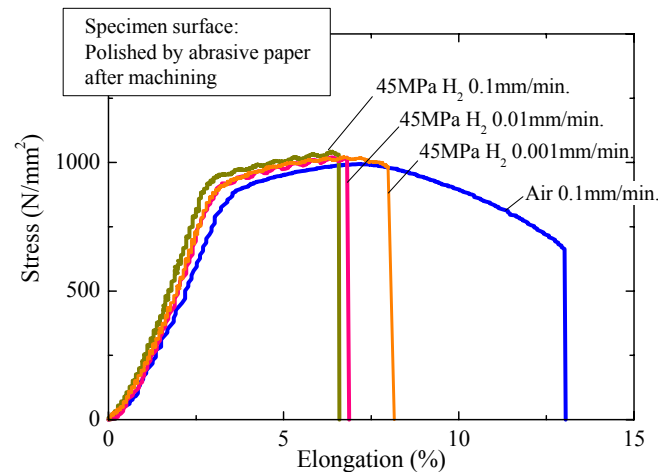
Figure 2 shows stress versus strain curves tested in various cross-head speeds using highly polished specimen (0.5 $\mu\text{m}$ ) in 45MPa gaseous hydrogen at room temperature. There were no significant differences in tensile deformation behaviors between air environment and 45MPa hydrogen until the maximum load point. However, hydrogen tested specimen ruptured with less ductility and characterized by many cracks originated from the surface (Figure 2). Figure 3 shows surface cracks of tension specimen observed after tested in 45MPa gaseous hydrogen. The two circumferential cracks seem to have originated from the specimen machining itself or possibly by

Figure 2 Tensile curves of SCM440-heat A under 45MPa gaseous hydrogen and 0.1MPa air

1. From the hydrogen tension test results on SCM435 and SCM440 steels, they ruptured with less ductility than in air and showed hydrogen embrittlement though the yield strength and maximum tensile strength were almost the same values as tested in air condition.
2. Though the specimen surfaces were electropolished, hydrogen tensile ductilities were scattered and this was found to be caused by the non metallic inclusions dispersed on the specimen surfaces.
3. Low cycle fatigue test results shows that the number of cycles to the crack initiation is less in 45MPa hydrogen than that in air.

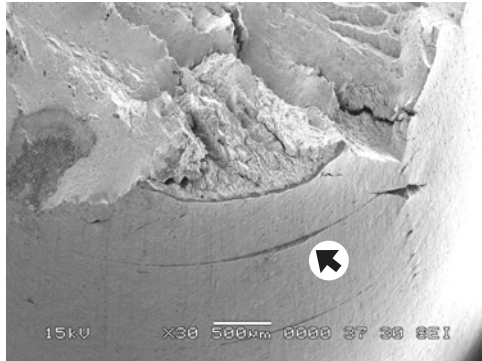
Figure 3 Surface cracks observed for hydrogen tested specimen of SCM435 (Specimen surface is polished by abrasive paper after machining)

the effect of cold work caused from specimen machining. Small cracks in line are found to be the dispersed non-metallic inclusions from EDS analysis. Five numbers of tests are duplicated on both electro polished condition and as-machined surface condition and ductility data are compared in Figure 4. Though the average ductility is improved by polishing effect, scatter in the reduction of area was observed. Figure 5 shows the fracture surface of electro polished specimen which ruptured with the poor ductility in comparison with the as-machined specimen. The examination of the fracture surface demonstrates that surface cracks disappears by polishing the surface, however the fracture origin was turned out to be the non-metallic inclusion (MnS) at the surface which is the cause of scatter in ductility. The strain rate controlled (0.1%/s) tension/compression low cycle

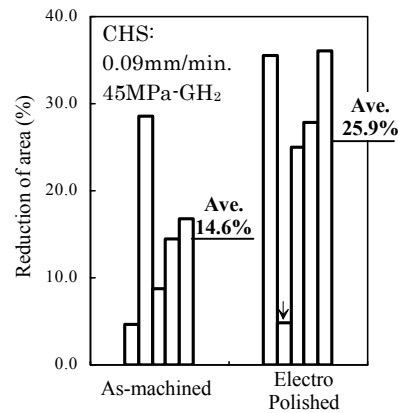
Figure 4 Duplicated tests results of tensile tests on differently surface prepared conditions of SCM435

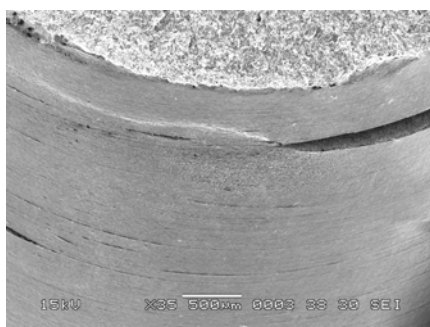
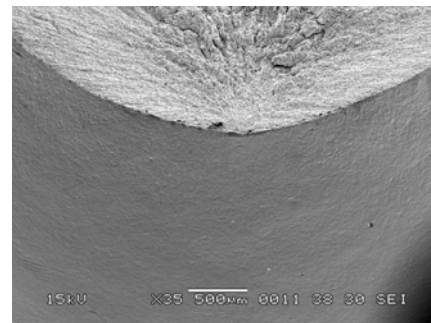
(a)

(b)

Figure 5 Fracture origin for as-machined (a) and electro polished (b) specimen of SCM435

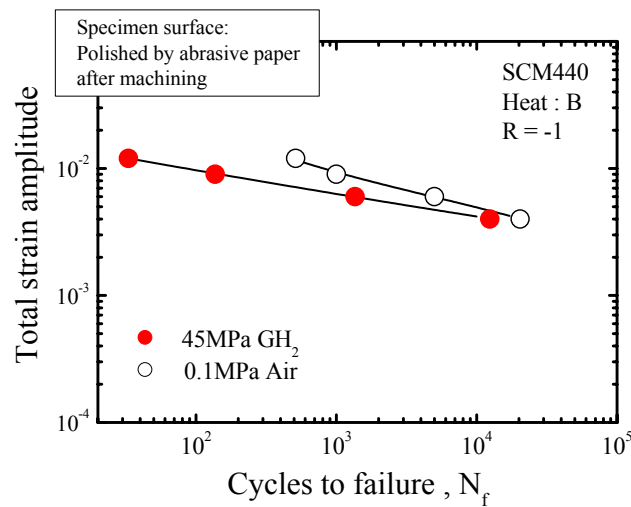
fatigue test on SCM440 steel results are shown in Figure 6. The specimen surfaces are polished by abrasive paper conditions so that the specimen machining effect would be eliminated. We reached the preliminary results that the number of cycles to the crack initiation is less in 45MPa hydrogen than that in air. We plan to investigate the surface influence on crack initiation and crack growth behavior under gaseous hydrogen and present in final conclusions.

Figure 6 Effect of low-cycle fatigue life
