**Pacific Northwest  
National Laboratory**

Technical Letter Report

**Preliminary Assessment of NDE  
Methods on Inspection of HDPE  
Butt Fusion Piping Joints for  
Lack of Fusion**

May 2008

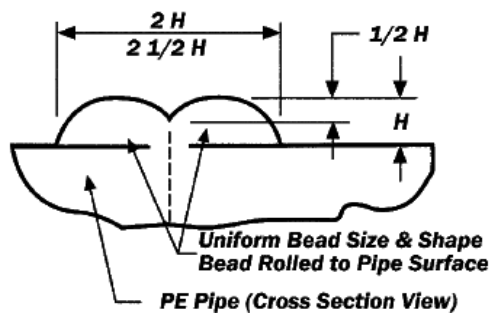
**Figure 3.1.** Butt Fusion Bead Dimensional Guideline (ASTM F2620-06)

According to the ASTM standard F2620 (ASTM F2620-06) on heat fusion joining of PE pipe, the weld bead should be rounded and uniform in size and shape on both sides and roll back to the pipe surface. The width of the beads should be approximately 2 to  $2\frac{1}{2}$  times the bead height. The v-groove between the beads should not be deeper than half the bead height (see Figure 3.1).

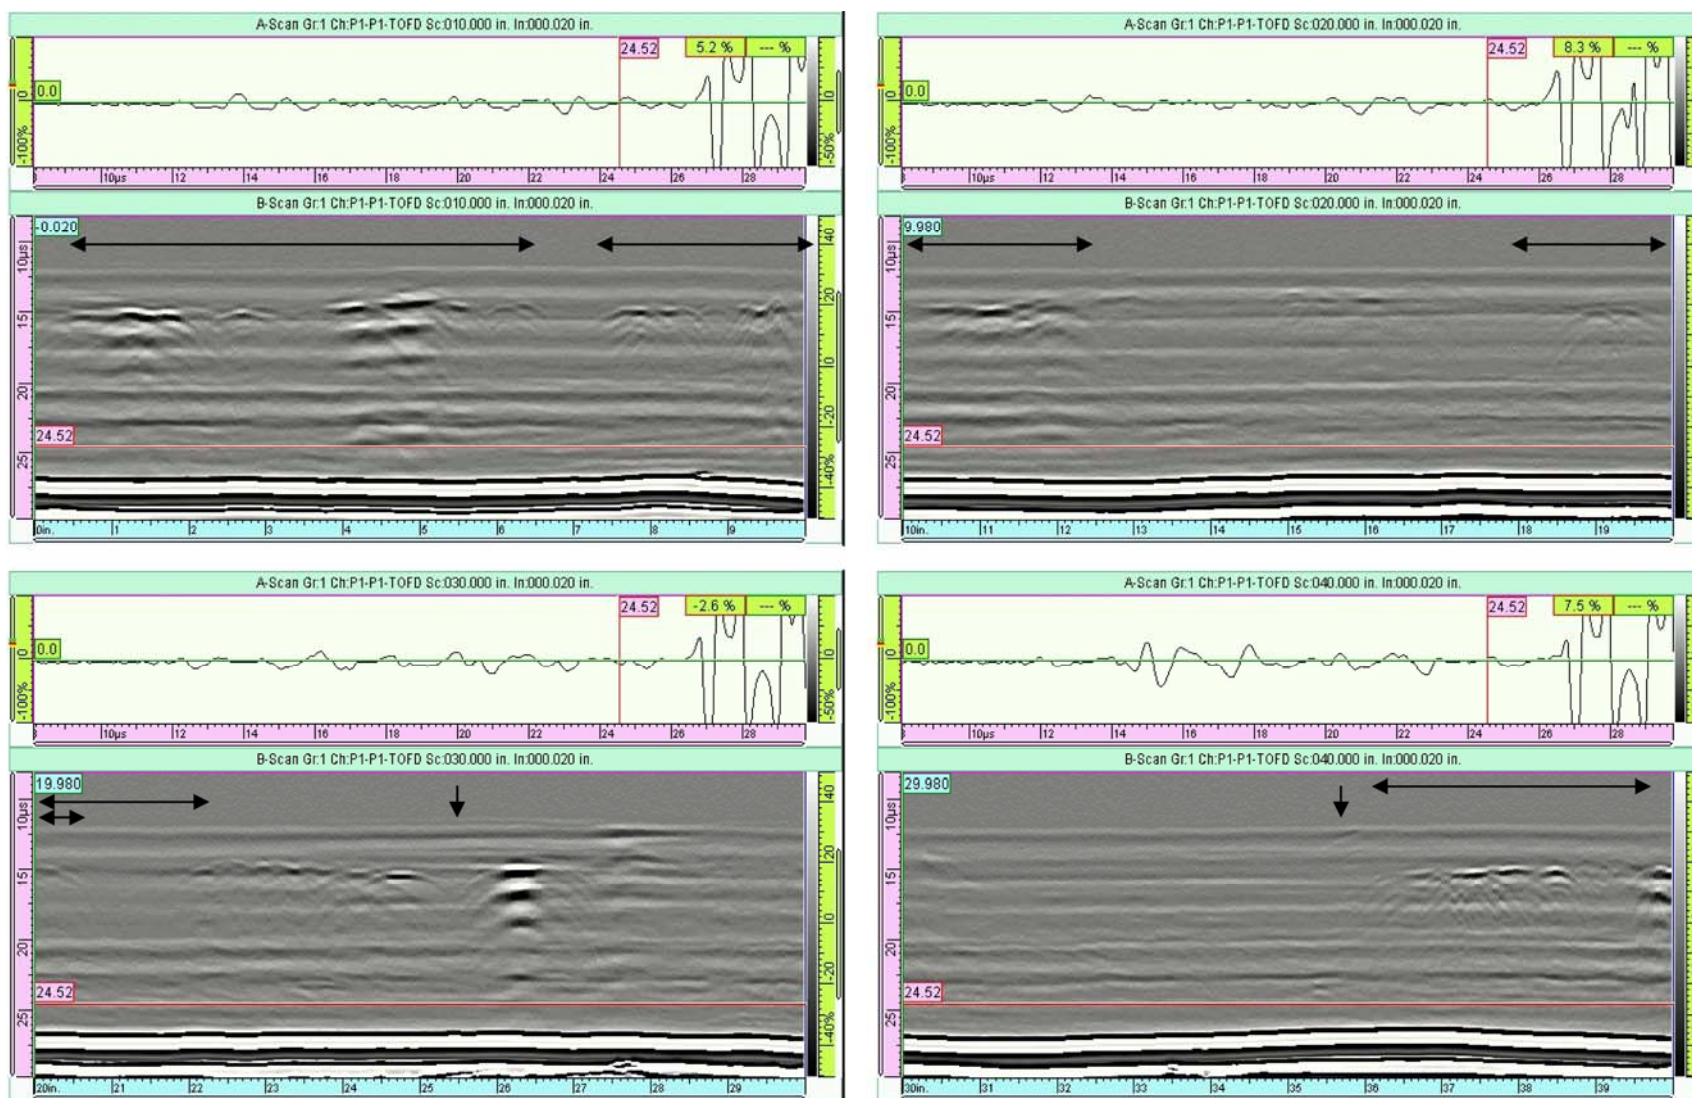
**Figure B.5.** HDPE Pipe 125, Condition 2

The worst-case condition for pipe fusion, out of the McElroy batch of 24 test assemblies, and the one most likely to produce LOF was condition 2 with fusion pressure during the heat cycle and a 20-second open/close time. One of these pipes was examined with TOFD by PNNL showing results comparable to those presented by Fluor/NDT Innovations, Inc. The data are shown in Figure 3.13 and Figure 3.14 for the four pipe quadrants, with the PNNL data shown in the top of each figure and the Fluor/NDT Innovations, Inc. data at the bottom of each figure. Notice that the PNNL data show the mode-converted signals beyond the longitudinal-wave back wall (ID) echo. The time window was extended to include the slower mode-converted signals with the thought that this additional data would enhance the detection of defects. The Fluor/NDT Innovations, Inc. data images are cropped at the ID and additionally do not have the saturated OD lateral wave signal seen in most TOFD images and in the PNNL data. This results in a cleaner looking image and should provide better near-surface sensitivity to flaws. Fluor/NDT Innovations, Inc. data is also much more sensitive, due most likely to their patented processing of the raw data. Regardless, in this data comparison flaw indications are identified at similar locations by both PNNL and Fluor/NDT Innovations, Inc. Each quadrant represents approximately 10 inches (25.4 cm) of pipe circumference.

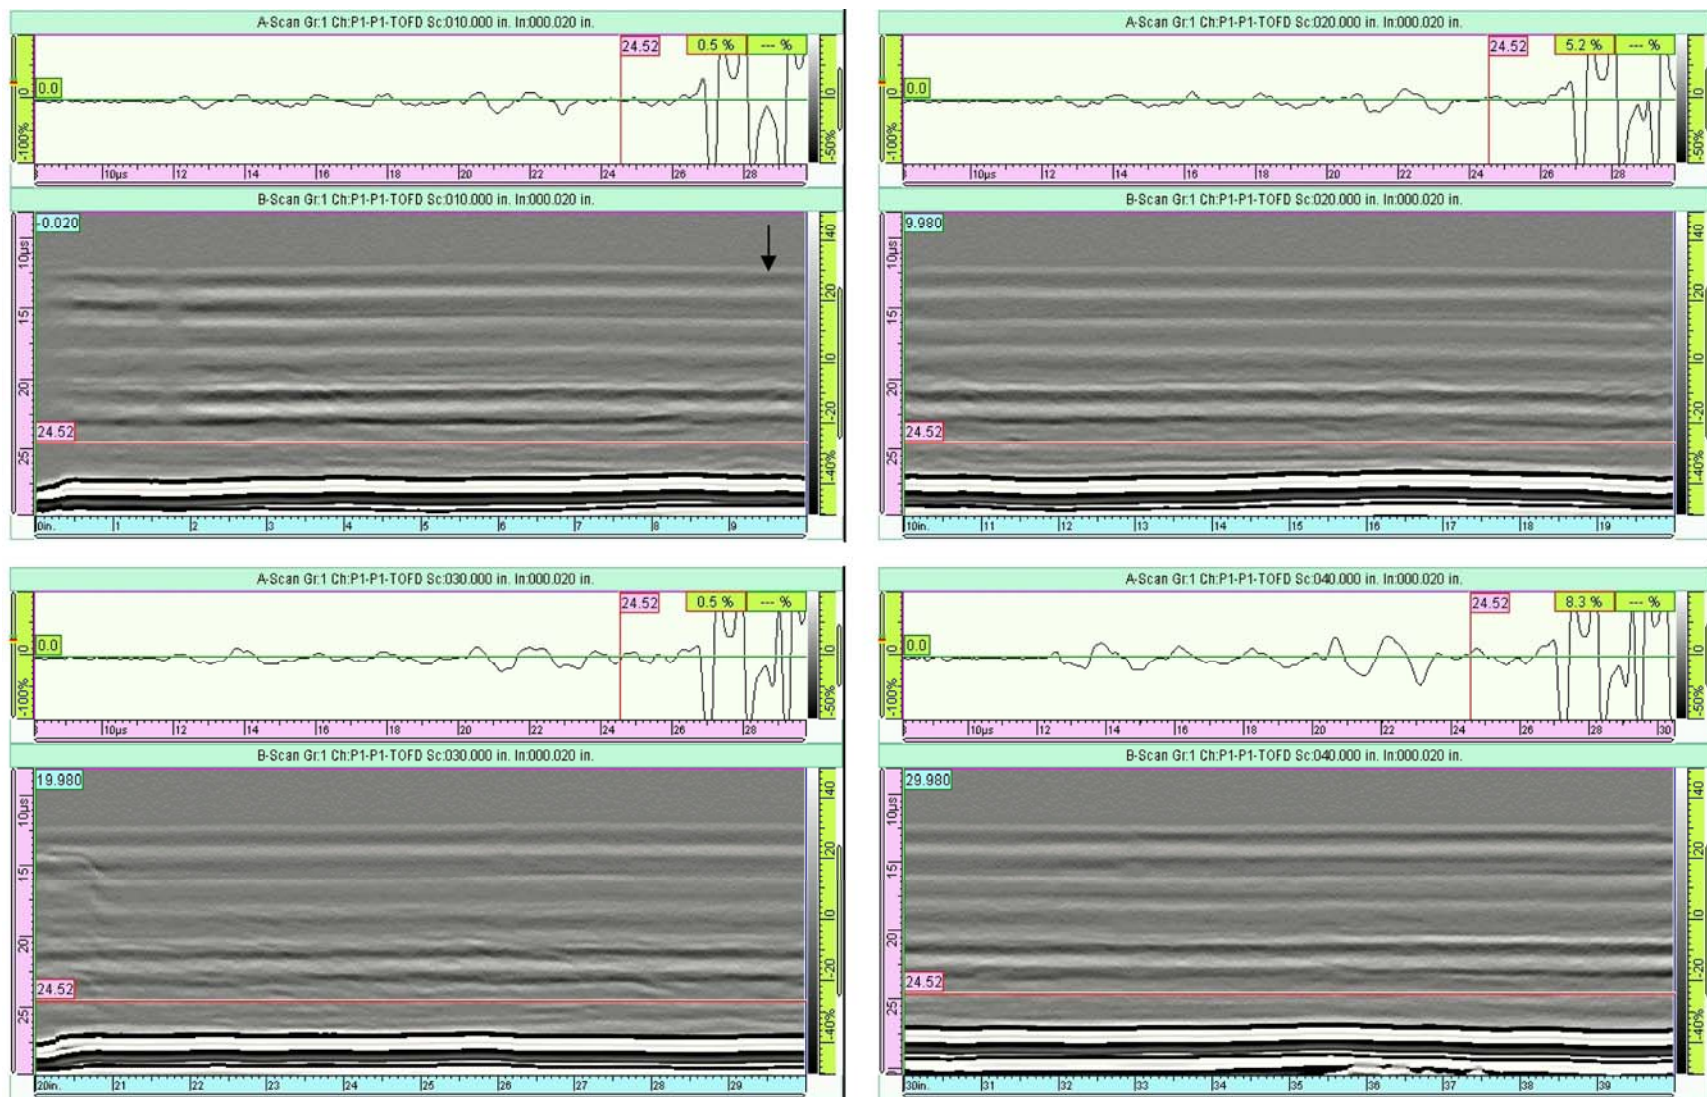
Figure B.24. HDPE Pipe 1224, Condition 6

For comparison a piece of a reportedly good weld was also evaluated. TOFD and PA ultrasonic examinations showed no indications in quadrant four of pipe 1224 at 3 to 4 inches (7.6–10.2 cm). This area was cut out and sectioned. Figure 4.7 shows a slice from this weld at approximately 3.4 inch (8.6 cm). As in pipe 125, streaks of light material due to uneven mixing with the dark carbon black pipe material are evident and make a lack-of-fusion detection from the slice difficult or impossible. The pipe surface after slicing appears to be a better indicator of the weld condition. Figure 4.8 shows the cut surface with no evidence of lack of fusion in the fusion zone.
