CAAP Quarterly Report

Project Name: Easy Deployed Distributed Acoustic Sensing System for Remotely Assessing Potential and Existing Risks to Pipeline Integrity

Prime University: Colorado School of Mines

Reporting Period: [10/01/2023 – 12/30/2023]

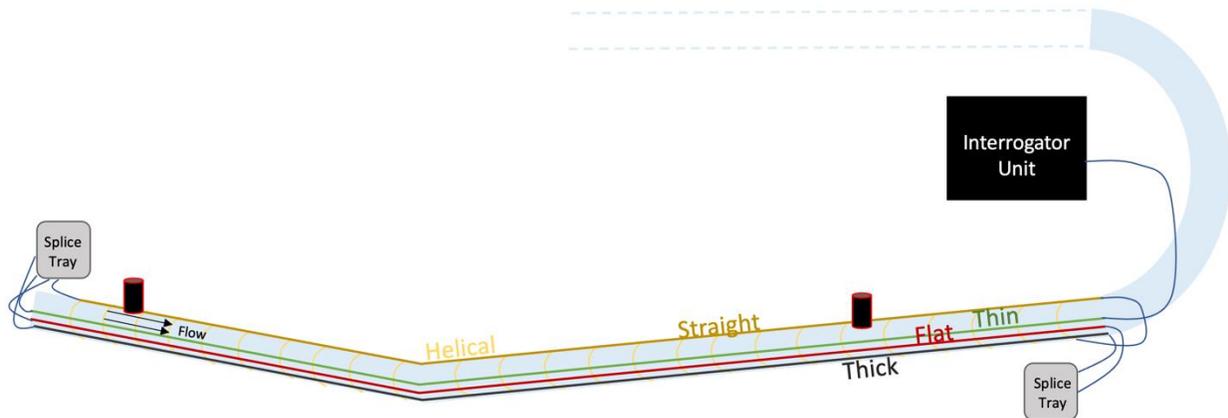
Figure 1. Schematic of Task #2 Layout depicting the interrogator unit spliced to a sequence of cables, including thin, flat, thick, straight, and helical sections. Two sensors are strategically positioned both uphill and downhill along the experimental segment of the flow loop. Notably, the pressure sensor situated on the downstream section was replaced with a higher frequency sensor.

- Modified the LabView program to enable the pressure recording frequency up to 10Hz, which better monitored the pressure fluctuations induced by slug flow.
- Repeated the experiments for 0.6 GPM under slug flow conditions at superficial gas velocity of 2, 4, and 6 m/s, with the new pressure recording frequency.
- Completed the experiments at another liquid flow rate (0.3 GPM) at various superficial gas velocities (18, 14, 10, 8, 6, 4, 2 m/s). The flow pattern is stratified flow (gas and liquid flow stably and separately) when the superficial gas velocity is greater or equal to 8 m/s, and slug flow (gas and liquid flow intermittently) for superficial velocities below or equal to 6 m/s. Figure 1 illustrates the schematic of the facility and fiber cable connections.
- Data processing was conducted which is discussed below along with the results.

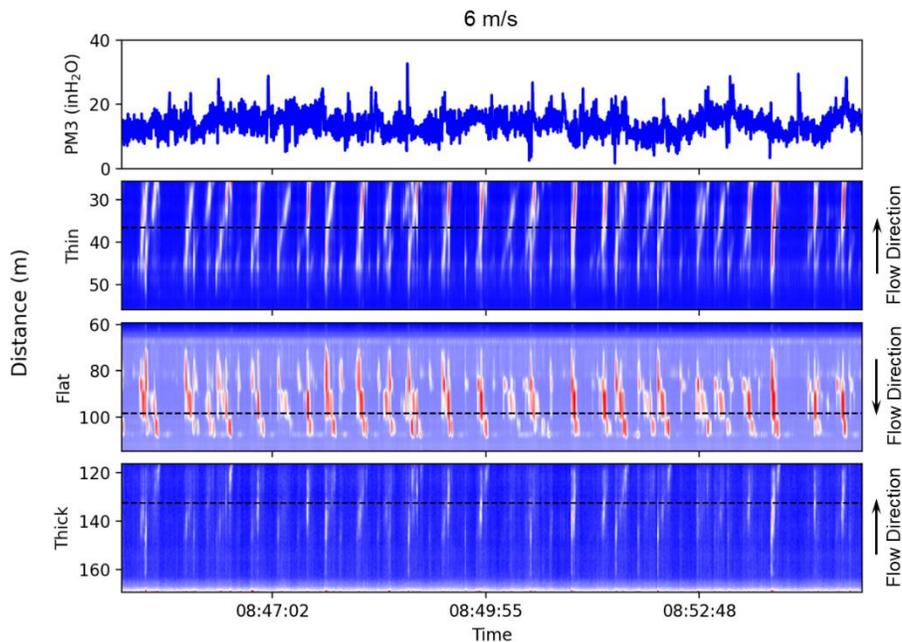
Figure 2. Processed standard deviation DAS data depicting the thin, flat, and thick cable sections, co-plotted with pressure sensor data (top). The black dashed lines on the thin, flat, and thick sections denote the position of the pressure sensor within each cable section. The observed slugging behavior is illustrated by slight, sloping trends in varying directions for each cable, indicating the slug's location at different times. The flow direction is also indicated by the black arrow on the right. The current superficial gas velocity is 6 m/s, and the liquid flow rate is 0.6 GPM (superficial liquid velocity is around 0.005 m/s).

which the gas and liquid are flowing separately and stably, with minimal pressure fluctuations. On the other hand, the slug flow demonstrates intermittent flow behavior as illustrated in Figures 2-7.

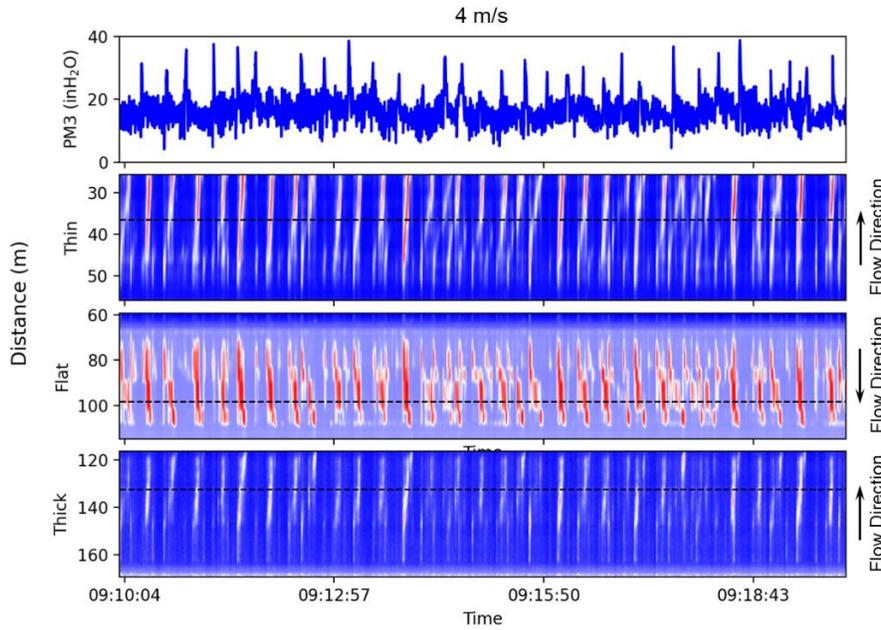
Figure 3. Processed standard deviation DAS data depicting the thin, flat, and thick cable sections, co-plotted with pressure sensor data (top). The black dashed lines on the thin, flat, and thick sections denote the position of the pressure sensor within each cable section. The observed slugging behavior is illustrated by slight, sloping trends in varying directions for each cable, indicating the slug's location at different times. The flow direction is also indicated by the black arrow on the right. The current superficial gas velocity is 4 m/s, and the liquid flow rate is 0.6 GPM (superficial liquid velocity is around 0.005 m/s).

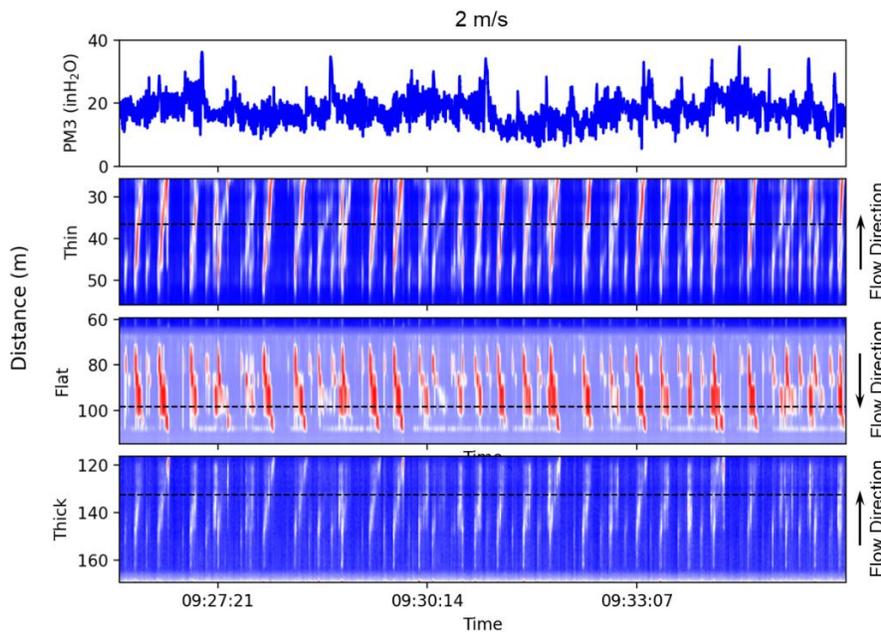
Figure 4. Processed standard deviation DAS data depicting the thin, flat, and thick cable sections, co-plotted with pressure sensor data (top). The black dashed lines on the thin, flat, and thick sections denote the position of the pressure sensor within each cable section. The observed

slugging behavior is illustrated by slight, sloping trends in varying directions for each cable, indicating the slug's location at different times. The flow direction is also indicated by the black arrow on the right. The current superficial gas velocity is 2 m/s, and the liquid flow rate is 0.6 GPM (superficial liquid velocity is around 0.005 m/s).

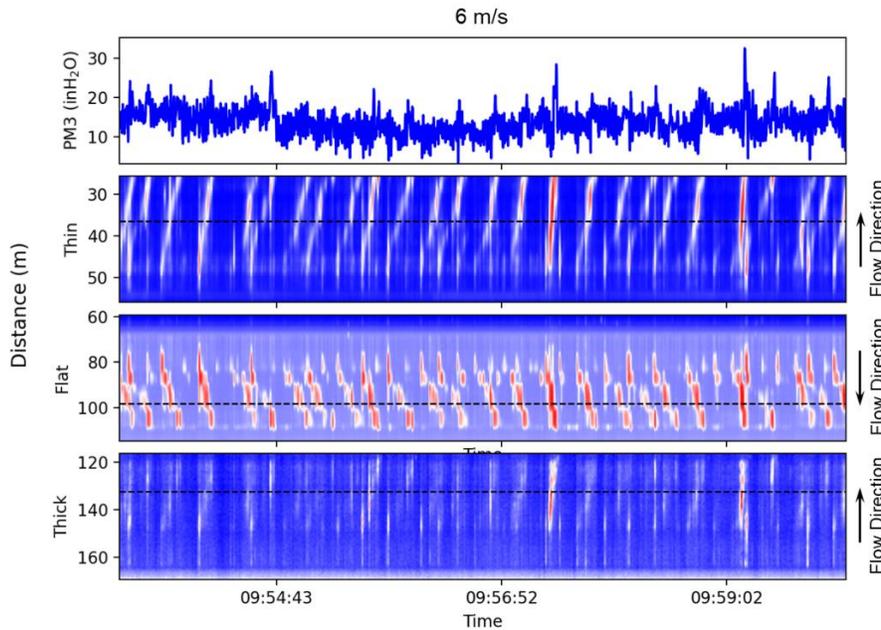
Figure 5. Processed standard deviation DAS data depicting the thin, flat, and thick cable sections, co-plotted with pressure sensor data (top). The black dashed lines on the thin, flat, and thick sections denote the position of the pressure sensor within each cable section. The observed slugging behavior is illustrated by slight, sloping trends in varying directions for each cable, indicating the slug's location at different times. The flow direction is also indicated by the black arrow on the right. The current superficial gas velocity is 6 m/s, and the liquid flow rate is 0.3 GPM (superficial liquid velocity is around 0.0025 m/s).

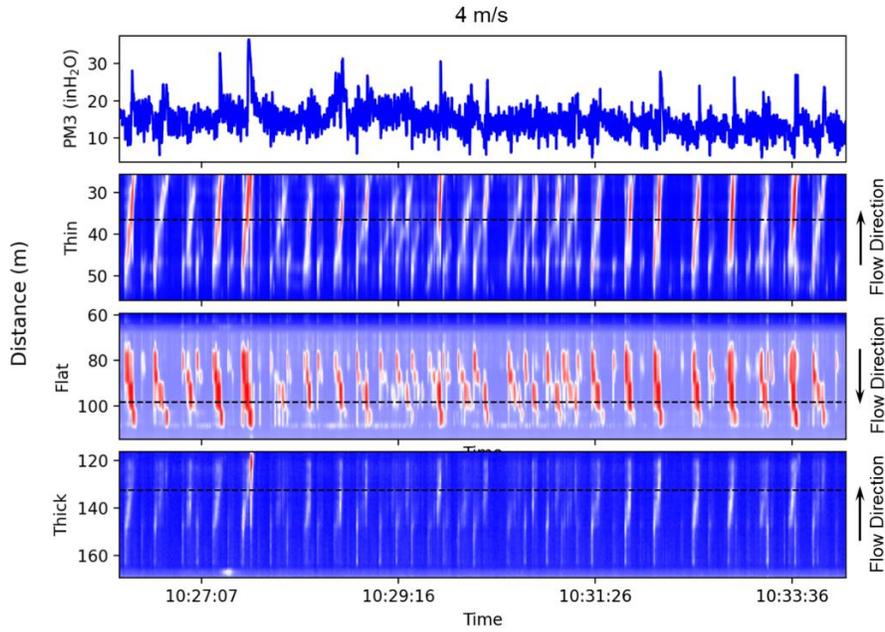
Figure 6. Processed standard deviation DAS data depicting the thin, flat, and thick cable sections, co-plotted with pressure sensor data (top). The black dashed lines on the thin, flat, and thick sections denote the position of the pressure sensor within each cable section. The observed slugging behavior is illustrated by slight, sloping trends in varying directions for each cable, indicating the slug's location at different times. The flow direction is also indicated by the black arrow on the right. The current superficial gas velocity is 4 m/s, and the liquid flow rate is 0.3 GPM (superficial liquid velocity is around 0.0025 m/s).

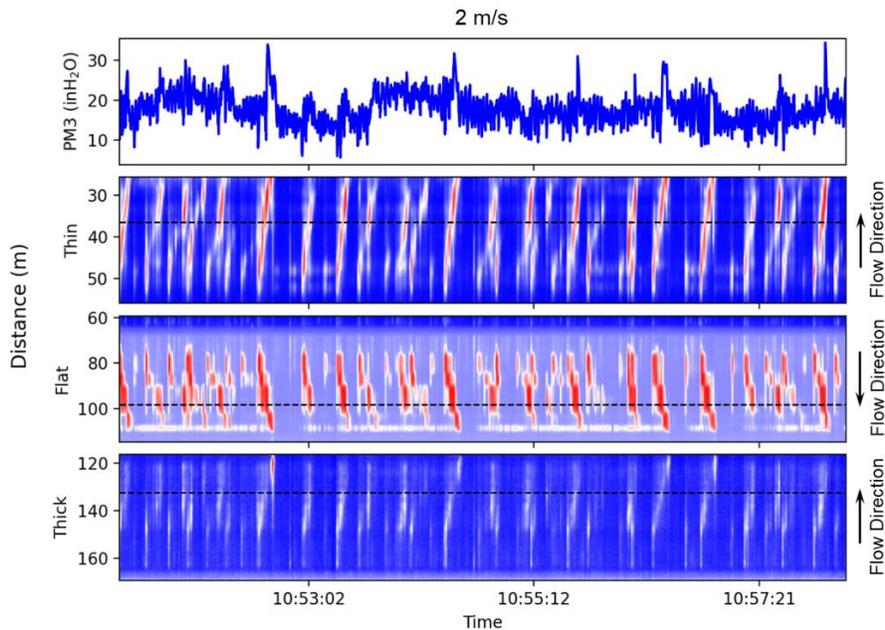
Figure 7. Processed standard deviation DAS data depicting the thin, flat, and thick cable sections, co-plotted with pressure sensor data (top). The black dashed lines on the thin, flat, and thick sections denote the position of the pressure sensor within each cable section. The observed

slugging behavior is illustrated by slight, sloping trends in varying directions for each cable, indicating the slug's location at different times. The flow direction is also indicated by the black arrow on the right. The current superficial gas velocity is 2 m/s, and the liquid flow rate is 0.3 GPM (superficial liquid velocity is around 0.0025 m/s).

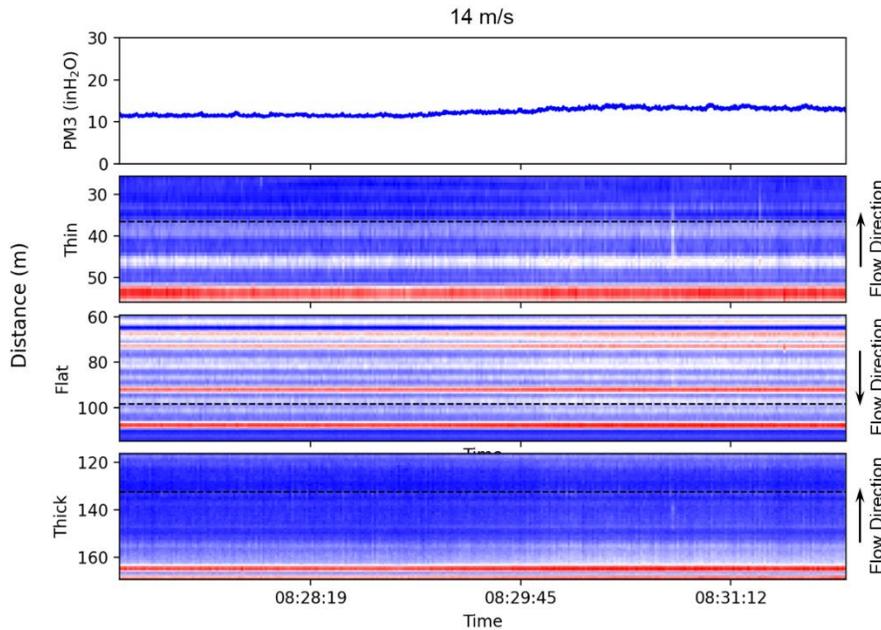
Figure 8. Processed standard deviation DAS data depicting the thin, flat, and thick cable sections, co-plotted with pressure sensor data (top). The black dashed lines on the thin, flat, and thick sections denote the position of the pressure sensor within each cable section. The flow direction is indicated by the black arrow on the right. The flow pattern is stratified flow. The signal does not vary much with time, indicating stable fluid flow behaviors as it should be in stratified flow. The current superficial gas velocity is 14 m/s, and the liquid flow rate is 0.3 GPM (superficial liquid velocity is around 0.0025 m/s).

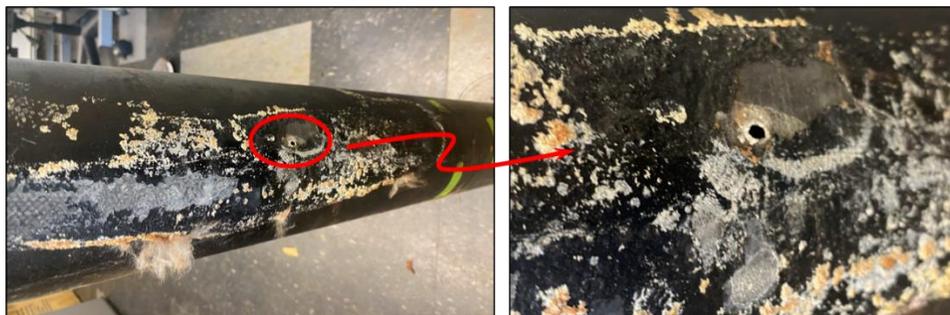
Figure 9. Photograph of the 1-m corroded pipe with minor leakage (~2mm) at pipe bottom

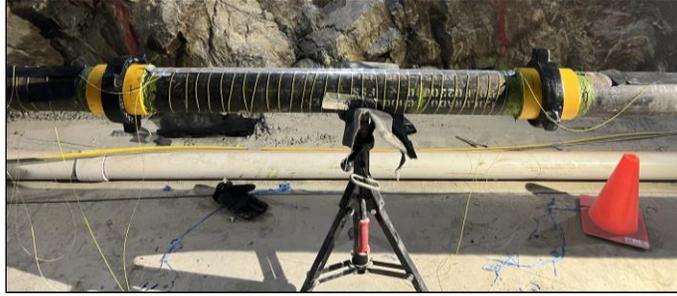
Figure 10. photograph of the 1-m corroded pipe with the minor leakage connected to the steel pipe using hammer unions

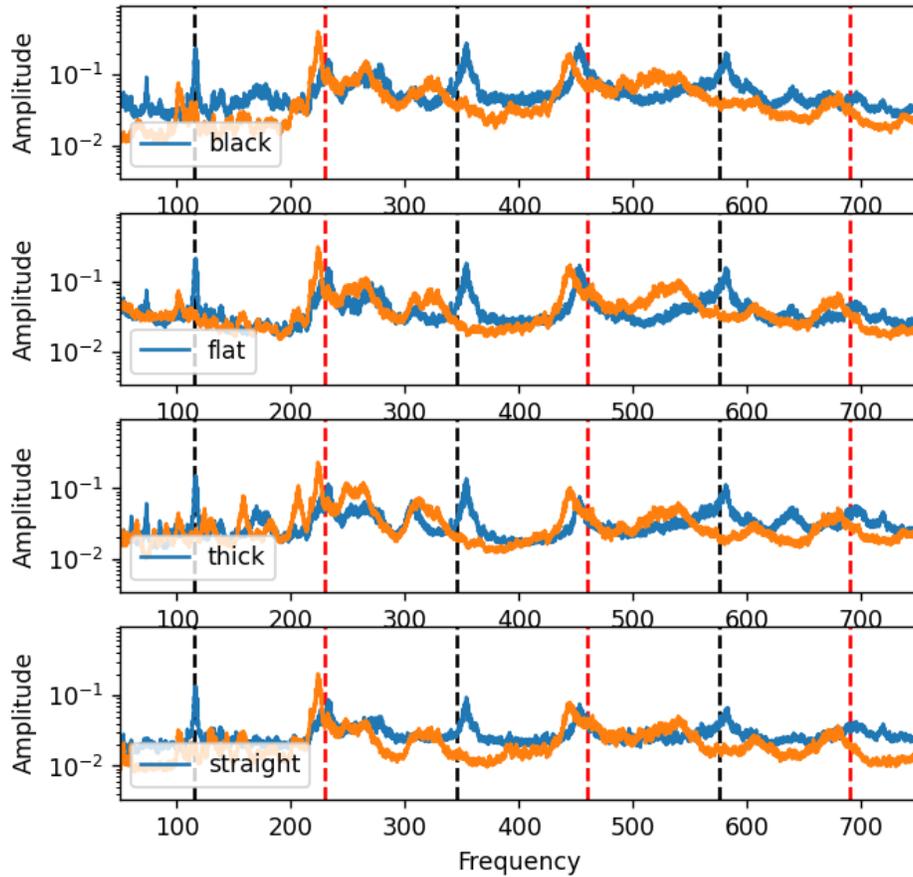
Figure 11. Pipe vibration spectrum recorded at different cables during control test (blue) and severe corroded pipe (orange). The gas flow rate is 10 m/s. Black dashed lines show even number modes while the red dashed lines show odd number modes.

Corrosion has reduced the material in the pipe section, leading to a thinner wall and lighter weight of the 1-meter section, potentially altering the entire pipe's resonant frequencies. Figure 11 presents a spectrum comparison between the control test and the corroded case at a 10 m/s flow rate. Although the spectra recorded by different cables are consistent, the resonant frequencies differ significantly between the control and corroded tests. Notably, the change in even-number modes (with the largest amplitude in the pipe's middle section, where corrosion is prevalent) is more pronounced than in odd-number modes. This difference, however, is likely attributable to the hammer union joints' alteration of the pipe's elastic properties, rather than the corrosion itself. A control test incorporating hammer union connections will be conducted next quarter to establish a more comparable control group for identifying corrosion-related signal changes.

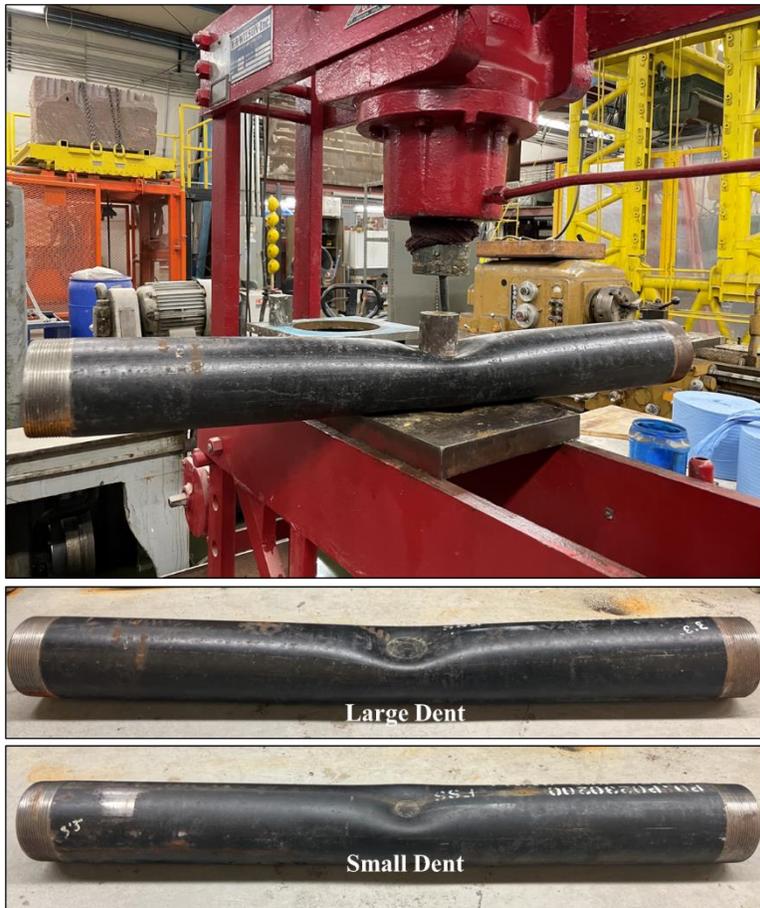
Figure 12. Photograph of the facility that created the dents and the 1-m test sections with two dent sizes.

During this reporting period, we completed the testing of two dented pipes prepared in the previous quarter (Figure 12). One pipe showcased a substantial deformation, simulating a significant structural compromise, while the other presented a smaller dent, simulating a less severe scenario. Figure 13 illustrates the facility with the dented pipeline positioned at the center of the steel pipe. We conducted experiments on both pipes, testing five different flow rates (2, 6, 10, 14, 18 m/s). The resulting data were compared to experiments conducted on the central 1-m section of the pipe without defects, serving as our baseline or control experiment in the data processing workflow section.

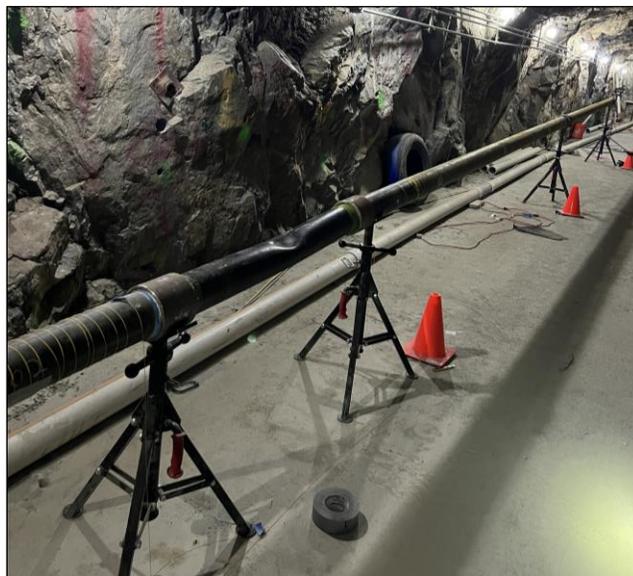
Figure 13. Photograph of the 1-m pipe with large dent positioned at the center of the steel pipe

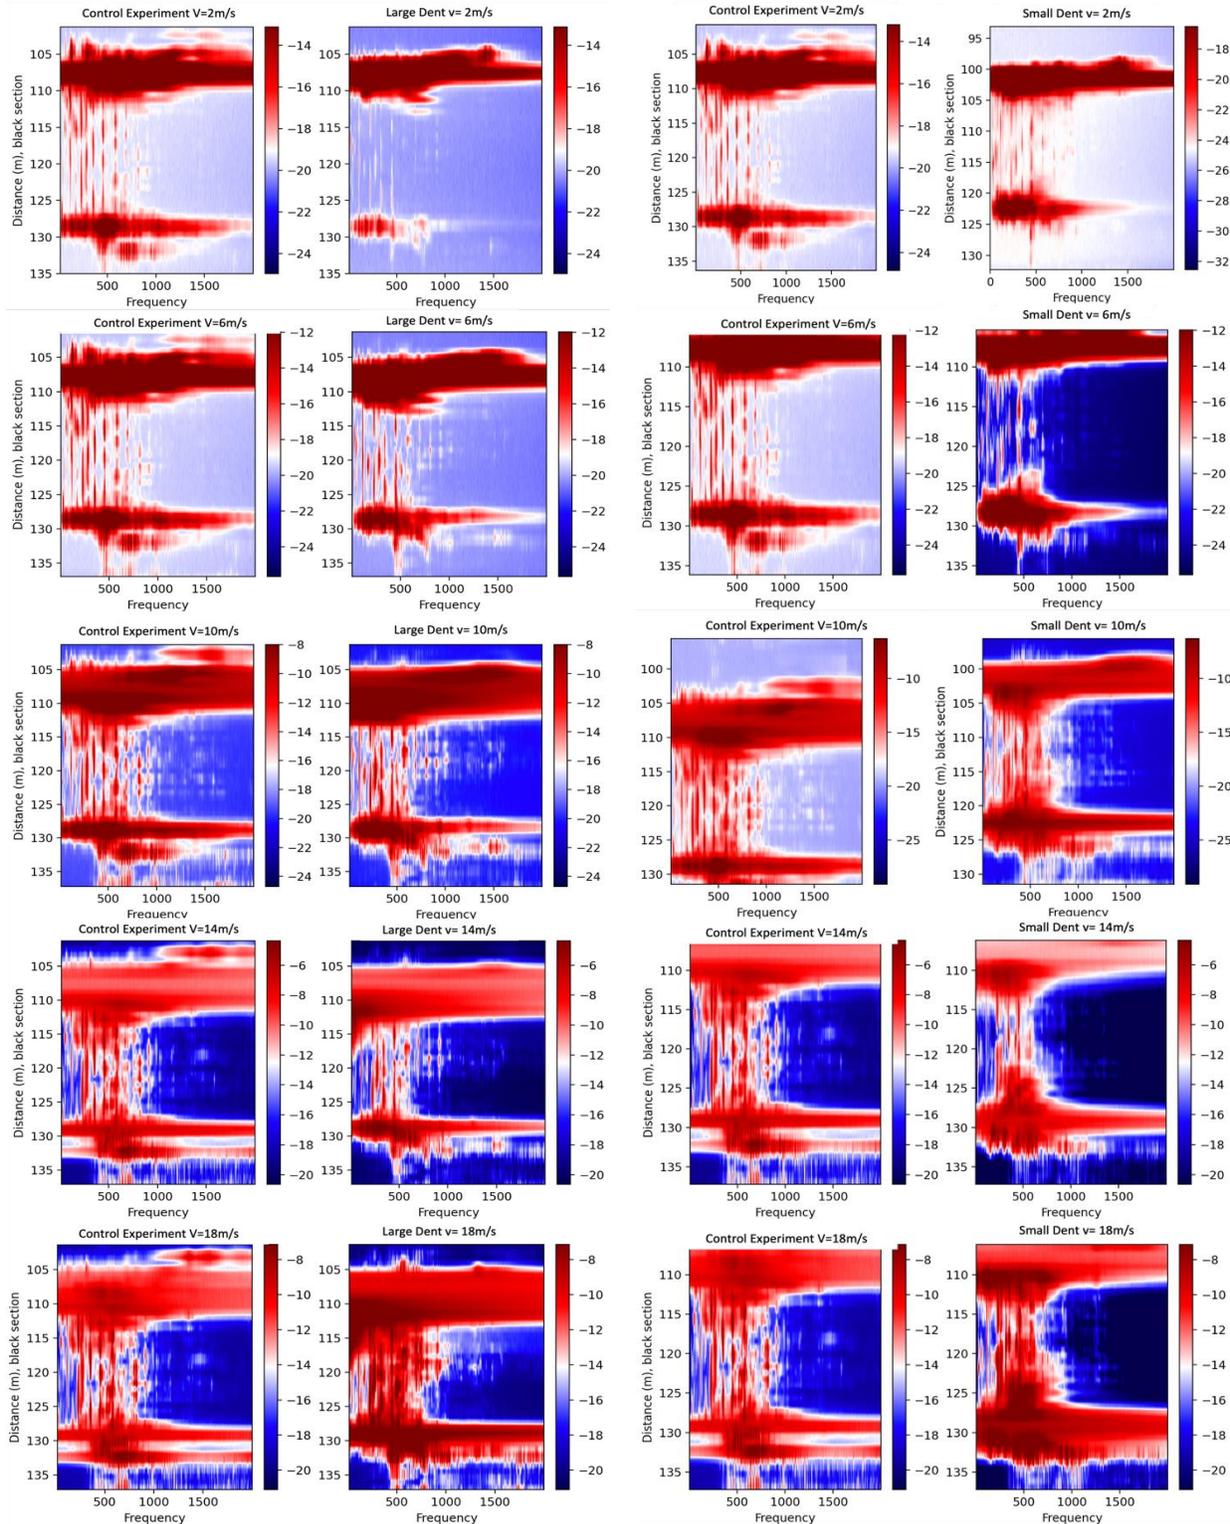
(a) Large dent

(b) small dent

Figure 14. 2D spectra of black cable section with varying flow rates for large dented (a) and small dented (b) pipes.

In our analysis, raw DAS data were segmented into 10-second intervals, and amplitude spectra were computed for each channel. To enhance statistical reliability, spectra obtained from 4-minute measurements during the same experiments were stacked and averaged. These resulting spectra were organized into 2D arrays, where each column represented spectrum amplitude for a specific frequency, and each row corresponded to the amplitude spectrum for an individual channel. Figure 14 depicts the 2D spectra obtained from experiments involving large and small dents, respectively, compared to the baseline experiment.

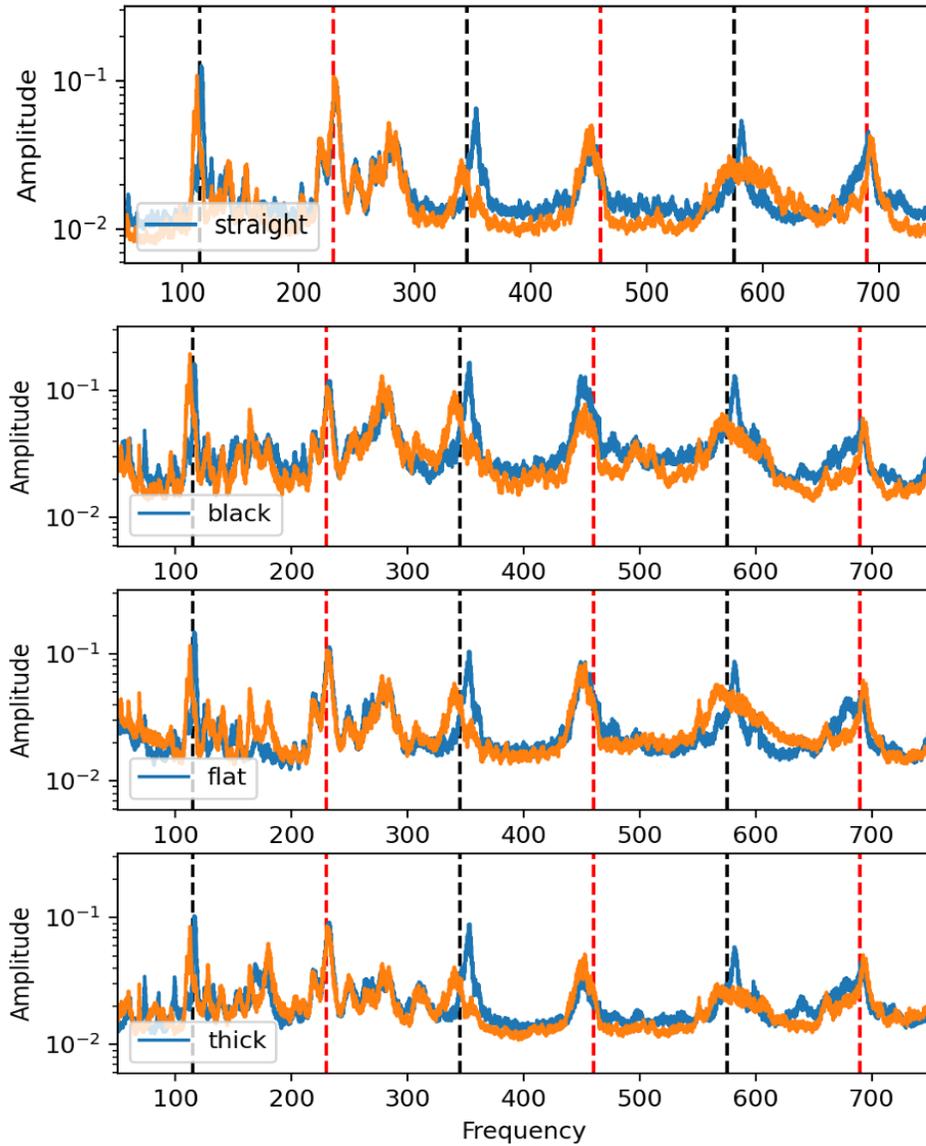
Figure 15: Vibration frequencies measured by different cables (large dent). Orange line presents data from the dented pipe while Blue line is data from the control experiment

To further comprehend the dataset, we calculated pipe vibration frequencies measured by different cables. Figure 15 and Figure 16 present the vibration frequencies for large and small dents, respectively. An intriguing observation was the shift in frequencies for only even-indexed modes (indicated by black dashed lines) between the dent (orange line) and control (blue line), while odd-indexed modes (red dashed lines) did not exhibit a frequency shift. This phenomenon can be explained by the fact that even modes display the highest amplitude at the pipe center, making them more sensitive to structural changes there, whereas odd modes possess zero amplitude at the pipe center, rendering them insensitive to the dent presence at the center of the pipe.

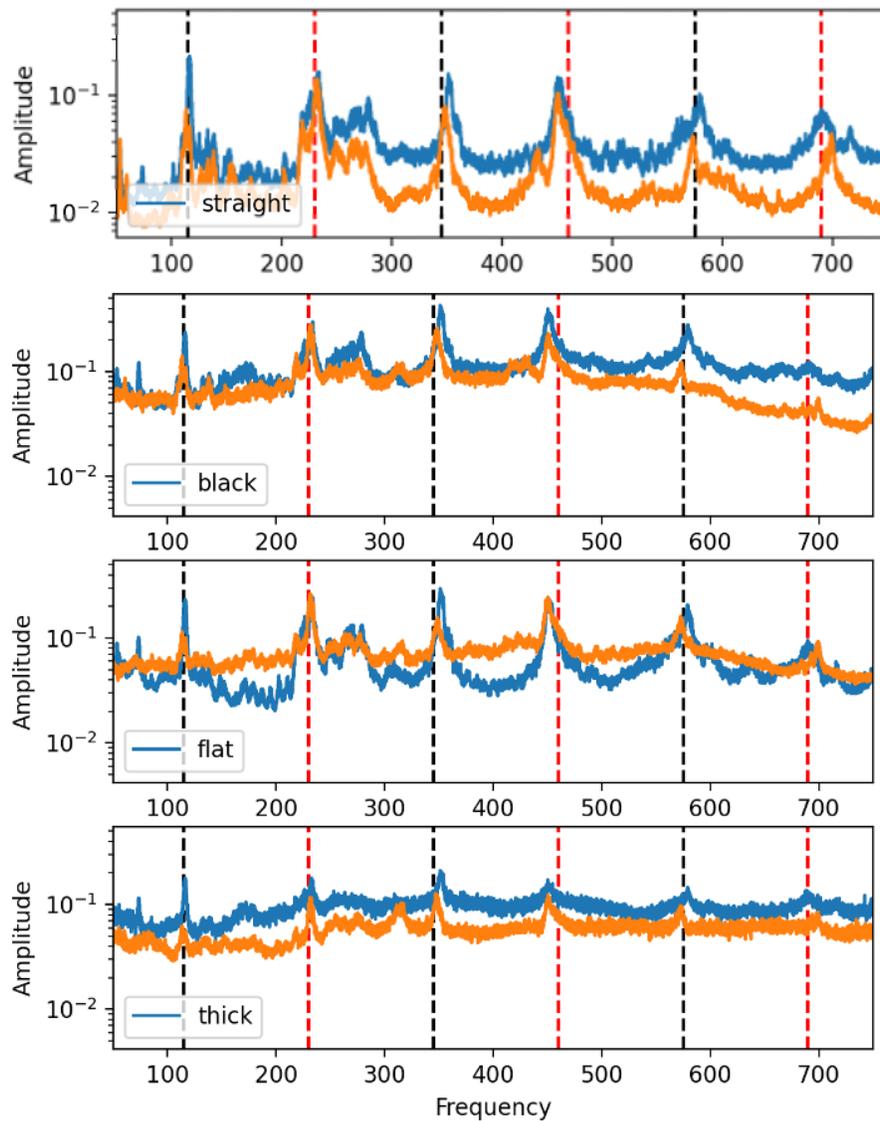
Figure 16: Vibration frequencies measured by different cables (large dent). Orange line presents data from the dented pipe while Blue line is data from the control experiment

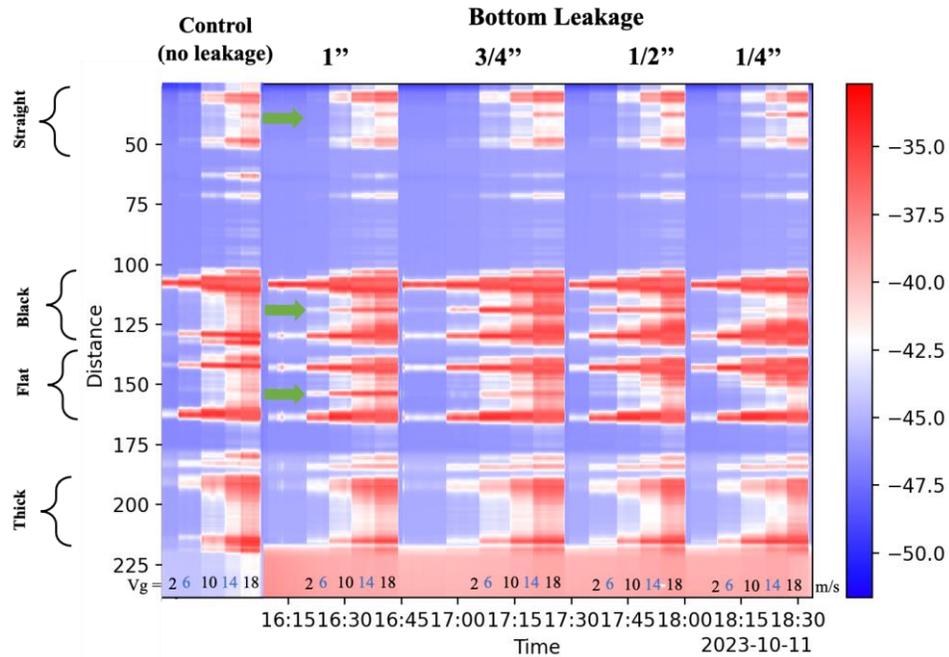
Figure 17. Magnitude of standard deviation values along the fiber during the experiment on October 11th, 2023. For each hole size, the flow rate changes from 2, 6, 10, 14 and 18 m/s. The gas velocities are indicated at the bottom of the image.

The figure displays the vibration intensity for four distinct types of cables during the experiment conducted on the same day. The study commenced with a control experiment featuring no leakage, followed by the sequential introduction of 1", ¾", ½", and ¼" leakage holes at the bottom of the test pipe. For each hole size, flow rates of 2, 6, 10, 14, and 18 m/s were examined. Figure 17 clearly reveals variations in fiber vibration intensity at different flow rates, with higher flow rates inducing stronger vibrations across all cable types.

Notably, more intense vibrations are visible near the pipe's center, where the leakage was introduced, for straight, black, and flat cables. The vibration anomaly appears to diminish with decreasing hole size and is entirely absent in the control tests.

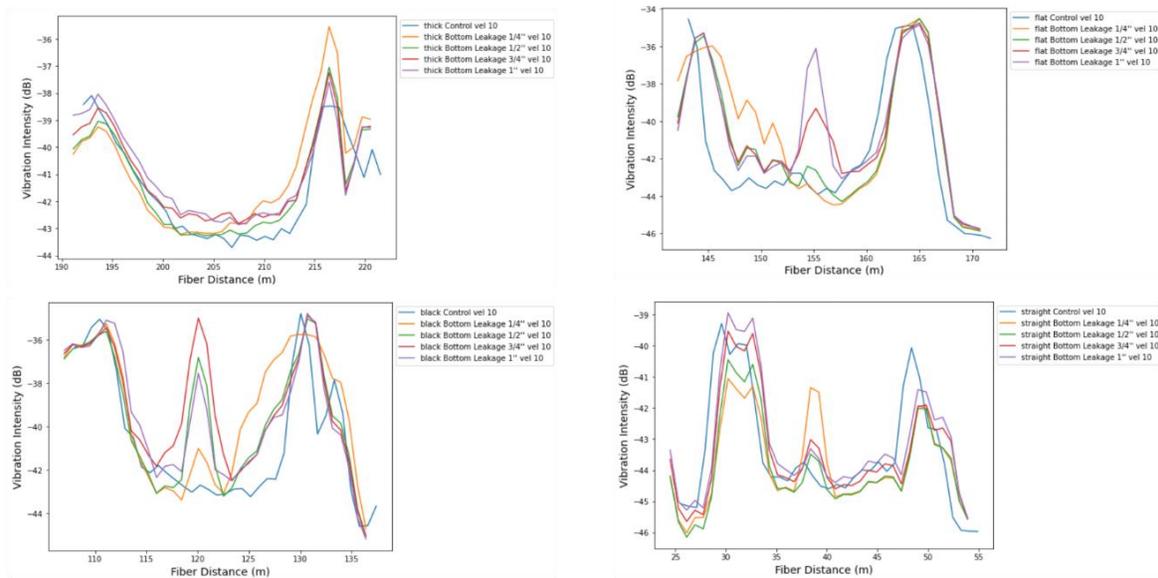
Figure 18. vibration intensity profiles in thick (upper left), flat (upper right), black (bottom left), and straight (bottom right) fiber sections during the leakage experiment. The different curves represent vibration intensities associated with varying leakage hole sizes at a flow rate of 10 m/s. Anomalies in vibration, induced by leakage holes and marked by blue arrows, are observable in three cable types when the hole size exceeds 1/2 inch.

Figure 18 illustrates the sensitivity of various cables to different leakage sizes, particularly at a flow rate of 10 m/s. The thick cable, being notably heavier, shows the least sensitivity to vibrations induced by the leakage. However, the other three cable types demonstrate varying degrees of sensitivity to detect the vibration anomaly caused by different leakage sizes. It's noteworthy that improving the mechanical coupling of the straight cable significantly contributed to enhancing its ability to detect the vibration anomaly caused by leakage, as depicted in Figure 18.

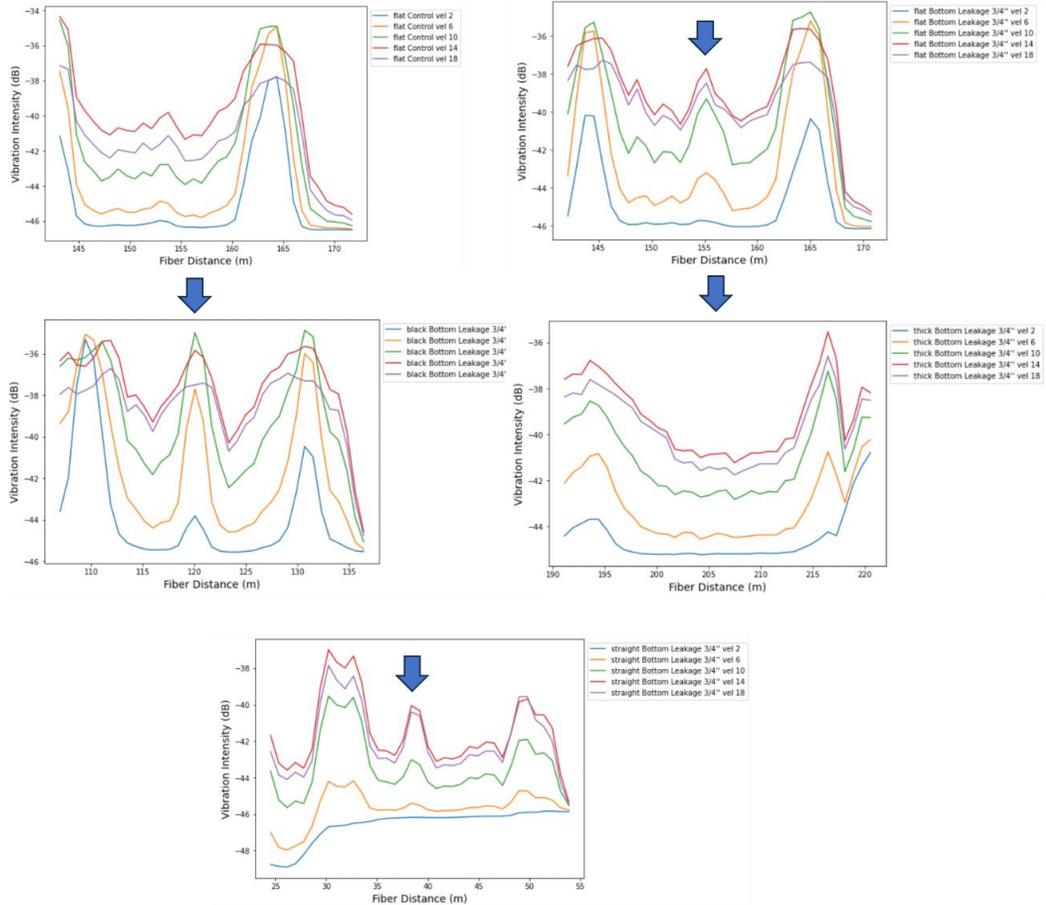
Figure 19. This figure compares the leakage detection sensitivity across different cable types at varying flow velocities. Top left shows a flat cable without leakage as a control experiment. Top right features a flat cable with a leakage hole size of 3/4 inch. The middle left, middle right, and bottom sections present the black, thick, and straight cables with the same leakage size, respectively.

Leakage detection sensitivity is also influenced by the gas flow rate within the pipe. Figure 19 illustrates the vibration distribution along the four fiber cables at different flow rates. For instance, in the control experiment, vibration intensity escalates with increasing flow rates for the flat cable, and no vibration anomaly is observable at the pipe's center. Conversely, in the experiment with a

½" leakage hole, a vibration anomaly is observable at all flow rates for straight, flat, and black cables, while the thick cable shows no such response.

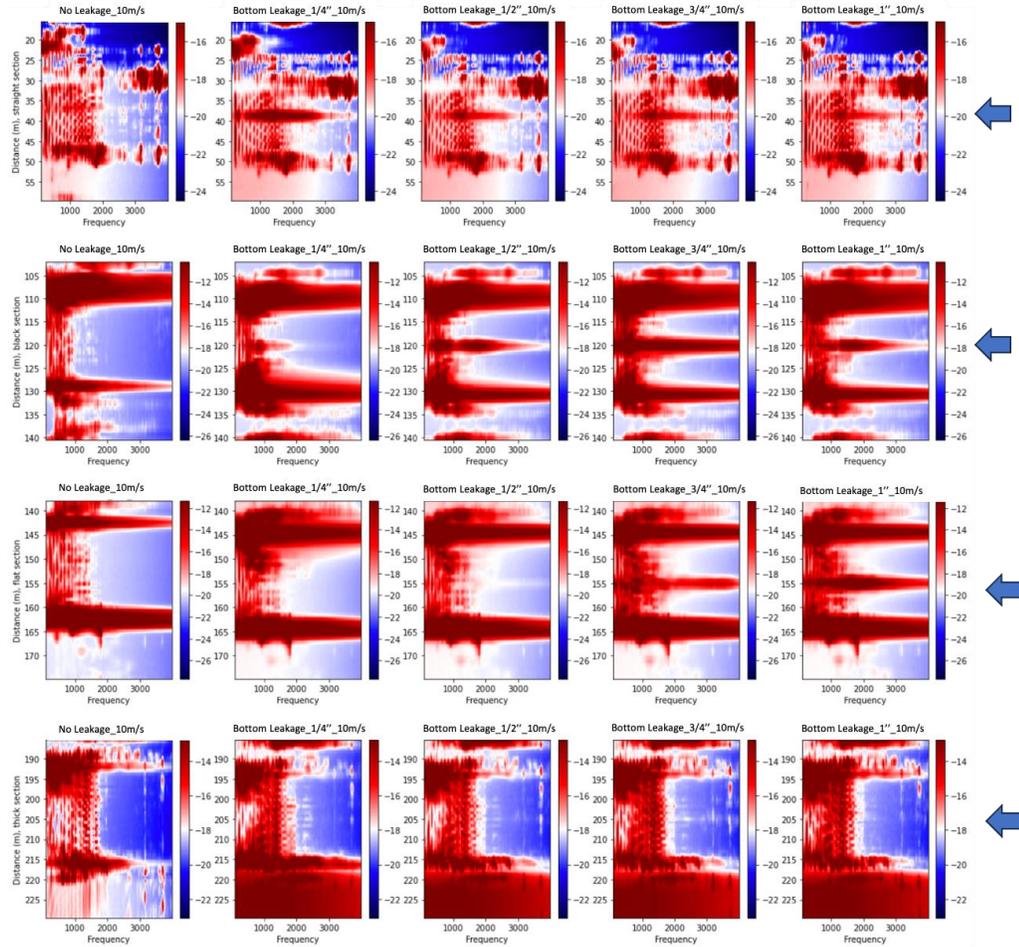
Figure 20. 2D spectra of fiber sections with varying leakage hole sizes at the bottom of the pipe, measured at a flow rate of 10 m/s. The top row displays the straight cable section, followed by the black, the flat, and the thick cable sections. Columns from left to right represent the control experiment (no leakage), followed by leakage sizes of 1/4", 1/2", 3/4", and 1", respectively. The color scale is measured in dB. Blue arrows show the leakage point location.

Figure 20 illustrates the 2-D spectra obtained from experiments involving various leakage sizes at the bottom of a pipe with a flow rate of 10 m/s. High amplitude spectra are conspicuously evident near the leakage points (indicated by blue arrows in Figure 20) for most cases involving straight, black and flat cables. However, the leakage point is less identifiable in the spectra of thicker cables.

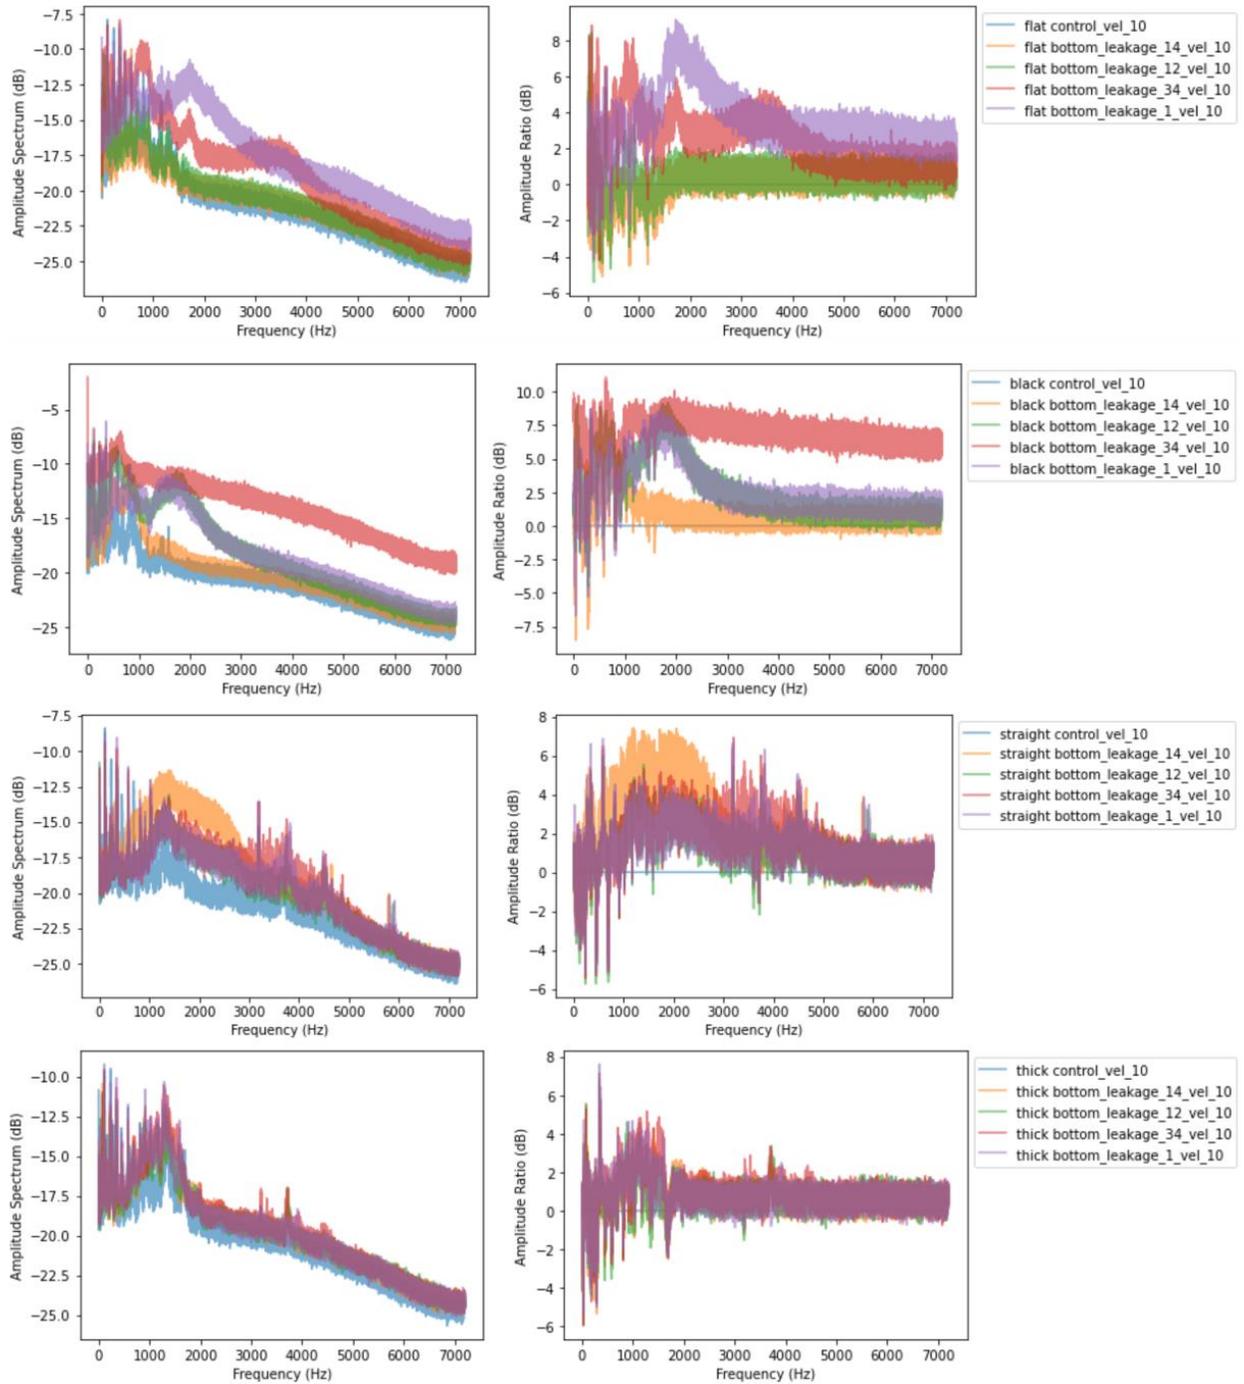
Figure 21. Amplitude spectrum at leakage point locations for various cables and leakage sizes. The flow rate is 10 m/s. The first row displays results for flat cable, the second row for black cable, the third row for the straight cable, and the fourth row for thick cable. The left column shows the amplitude spectrum, while the right column presents the ratio of amplitude spectrum between leakage experiments and the control experiment. All values are expressed in decibels (dB).

To visualize the amplitude spectrum induced by the leakage more clearly, we extracted the amplitude values corresponding to the leakage location from the 2D spectra and plotted them against frequency. Figure 21 presents the amplitude spectrum for experiments with different leakage sizes, all at a flow rate of 10 m/s. The right column of Figure 21 shows the amplitude ratio between the leakage and control (no leakage) experiments. Our findings indicate that the vibrational anomalies caused by leakage span a broad spectrum. For black cable, we observed up to a 10 dB increase in amplitude across most of the measured frequency range at the leakage point compared to the no-leakage scenario.

The spectral responses appear to be more complex for flat cable. For instance, with leakage sizes of ¼" and ¾", amplitude increases are more uniformly distributed across the entire frequency band, averaging between 1-2 dB. Conversely, for ½" and 1" leakage sizes, the amplitude increases are predominantly concentrated in the 1000-2000 Hz range, exceeding an average of 5 dB. This complex response to leakage is likely due to the flow interactions between the flat cable and the flow deviating from the main pipe into the leakage pathway. Similarly, the straight cable exhibits an amplitude increase concentrated in the same frequency range (1000-2000Hz range). In contrast, little amplitude increase can be observed on the thick cable, which is consistent with the STD results. At large leakage sizes, amplitude increase can be observed at a narrower frequency band, with 600-800 Hz for the ¾" leakage size and 1100-1300 Hz for the 1" leakage size.
